Eco-65 PRODUCT GUIDE – FERRULES

Load Test Report

B-Deck Lateral Load Test

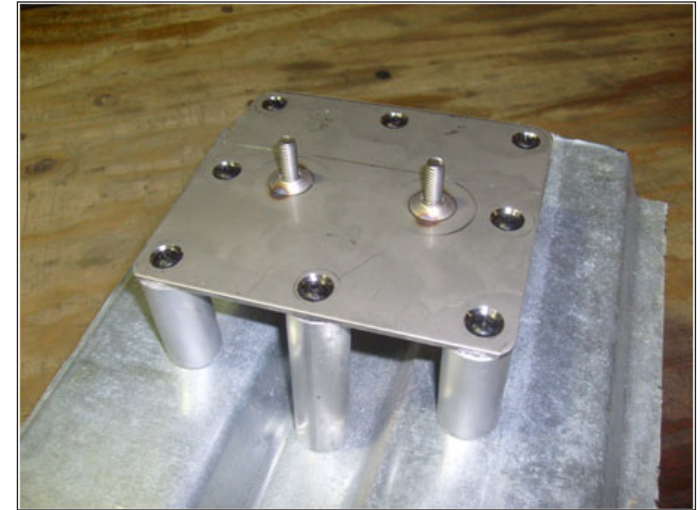
Fig. 1

For each test, a new EcoFasten base plate (Appendix B) was fastened to a 12"x12" square galvanized steel b-deck with eight new OMG XHD screws (Appendix C) on top of ferrules spacing the plate 2" from the top of the deck (Figure 1). The whole assembly was securely fastened to a welded steel structure which was bolted to the base of the testing machine. Insulation was omitted from the test because properties can vary significantly between different types of insulation.

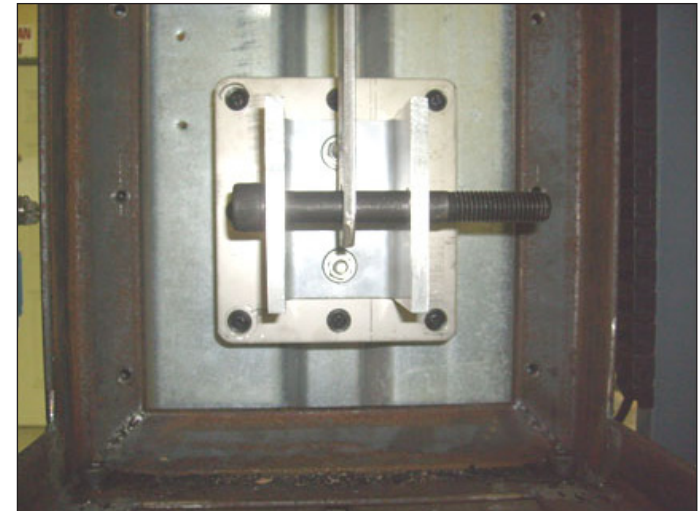
Fig. 2

To determine the maximum load the plate would sustain from any direction parallel to the base plate, three tests were conducted loading the plate vertically (Figure 2), and three tests were conducted loading the plate horizontally (Figure 3). These two conditions represent the two extremes of the range of possible directions the plate could be loaded. Custom brackets were fabricated for the two test configurations to connect the base plate to the load cell 2-5/8" above the plate. Loads were measured by an ASTM E74 calibrated load cell and display. Deflection was measured with an electronic digital indicator accurate to .0005" 2-5/8" above the plate.

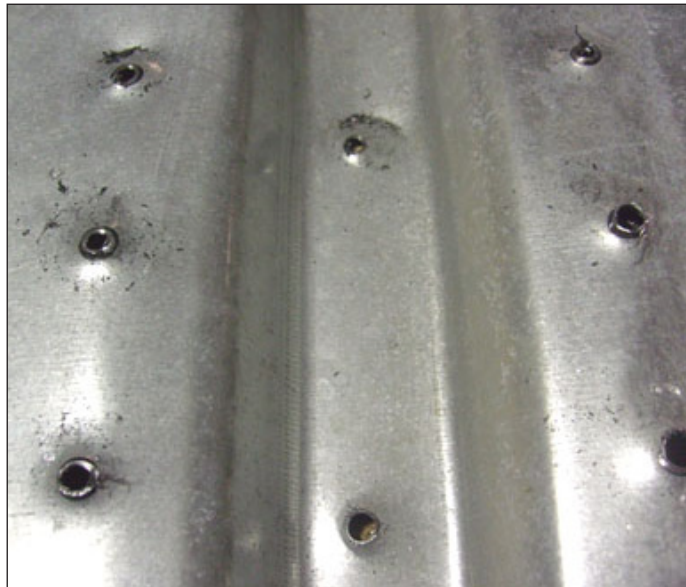
Fig. 4

Typical failure was the bottom middle screw pulling out of the steel deck. The rest of the screws loosened as the deck deformed (Figure 4). Deformation of the base plate was almost nonexistent.
