PFS TEST REPORT # 15-079 UPLIFT AND LATERAL LOAD TEST OF SIMPLEGRIP ASSEMBLY FOR ECOFASTEN SOLAR[®] MORRISVILLE, VERMONT

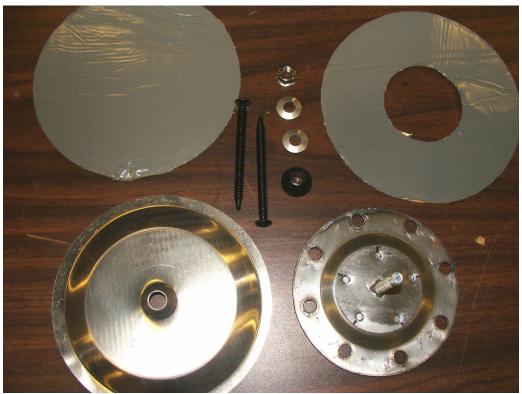
Photo 1: SimpleGrip Assembly Components

The SimpleGrip Assembly consisted of 2 circular Eternabond mastic pads – one with a hole cut out, a SimpleGrip base plate, 2 OMG XHD 2 inch screws, a simple seal bushing, a compression plate, 2 EPDM sealing washers, an L bracket and a flange nut (Photo 1). The SimpleGrip assembly (*Photo 2*) was provided by the client. The underlayment, the rolled roofing asphalt shingle and roof deck components were locally procured by PFS. The rolled roofing was TopSeal WeatherWood. The underlayment was #30 felt conforming to ASTM D4869. The deck sheathing was 1/2-in. CDX, 3-ply, PS1 grade mark stamped, 32/16 plywood.

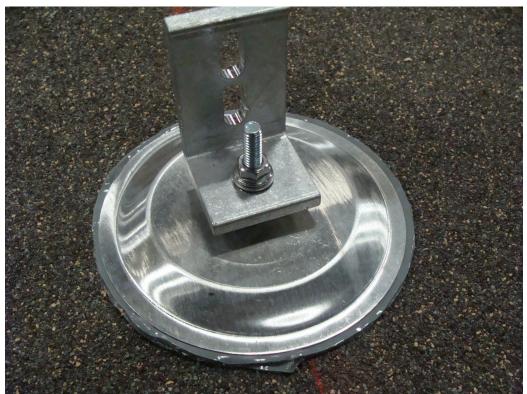
Photo 2: SimpleGrip assembled

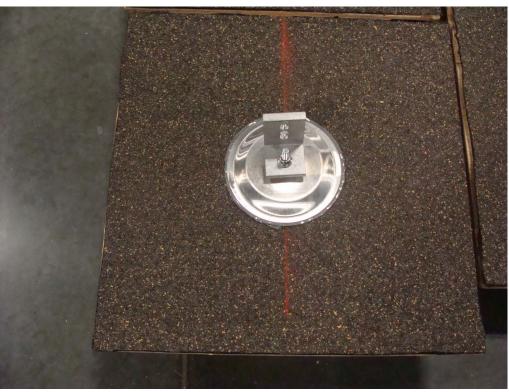
Photo 3: Test Deck Sample with SimpleGrip Assembly

Six mock-up roof decks 18-in. wide by 18-in. high were fabricated with the plywood sheathing and 2x6 SPF #2 lumber as a header and a joist in the middle. Six mock-up roof decks were built with 2x6 SYP #2 lumber as a header and a joist in the middle. The felt and rolled roofing shingle were applied on the deck, and the SimpleGrip assembly was installed at the center of the deck according to the manufacturer's installation guide (Appendix A). The mastic was centered on the test deck and then the SimpleGrip base was mounted on top of the mastic. The fasteners were then installed into predrilled holes in the central joist. A mastic pad was placed on top of the base plate followed by the simple seal bushing, compression plate, an EPDM washer, followed by the L bracket, another EPDM washer and the flange nut (*Photo 3*).

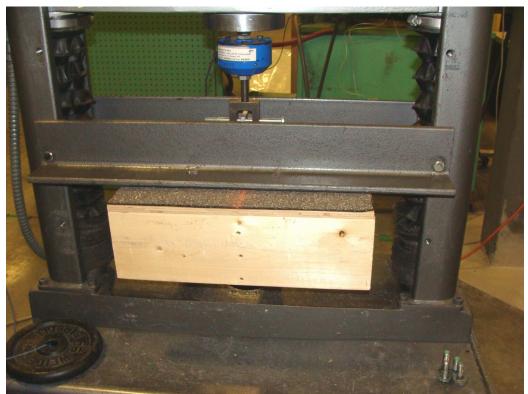
Photo 4: Typical Uplift Load Test Setup

The assembly was mounted on to a universal test machine such that the test deck could be fixed to the test frame, while the load could be applied on the bracket. Uplift testing was performed with test loads applied to the L-bracket vertical leg in a 90 degree direction away from the installed planar surface (*Photo 4*). Lateral testing was performed with the test load applied to the L-bracket parallel to the deck surface (*Photo 5*). A displacement sensor was mounted to monitor deformation of the bracket assembly relative to the deck surface. Testing was performed in sets of three replicates for each mode. The load was applied at a constant cross-head speed of 0.1-in/min until failure.

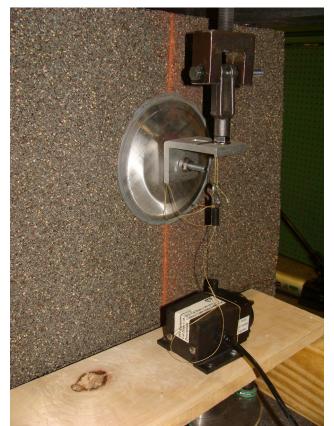
Photo 5: Typical Lateral Load Test Setup

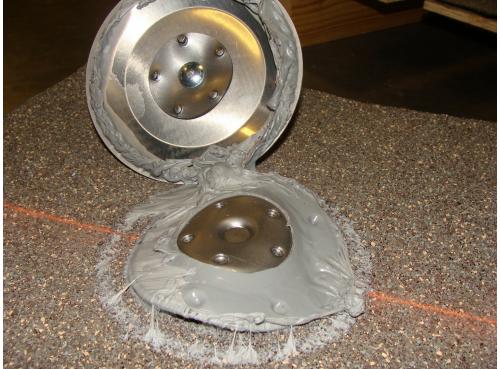
Photo 6: Typical Failure in Uplift Load Test

The failure mode in the uplift tests was due to gradual bending of the SimpleGrip base followed by release of the metal rivets (*Photo 6*). Failure of the lateral test assembly consisted of gradual rotation of the L bracket followed by failure of the metal rivets (*Photo 7, 8*).

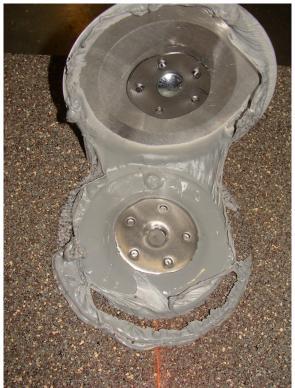
Photo 7: Typical Failure in Lateral Load Test

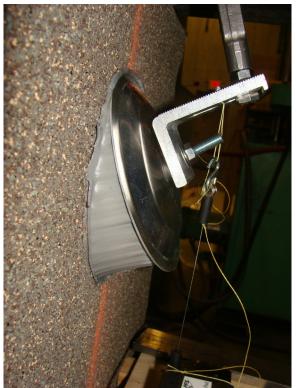
Photo 8: Typical Failure in Lateral Load Test

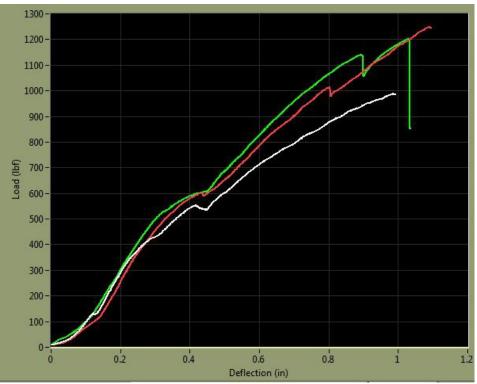
Photo 9: Load-Deflection Plot Uplift Test, SPF

A summary of the test results are shown below. The average uplift (withdrawal) failure load was 1147 lbf in SPF and 1128 lbf in SYP. The average lateral failure load was 942 lbf in SPF and 1029 in SYP when the load direction was parallel to the deck surface. The load at 1/8-in. deflection was interpolated from the load-deflection data. Load-deflection plots are shown in Photos 9-11.

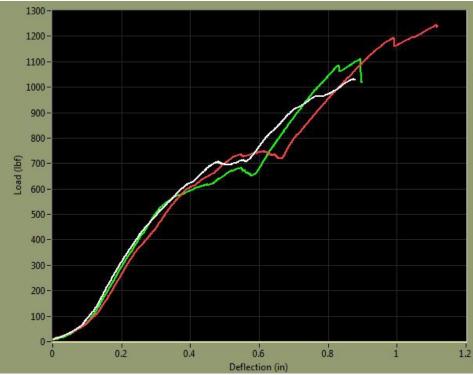
Photo 10: Load-Deflection Plot Uplift Test, SYP

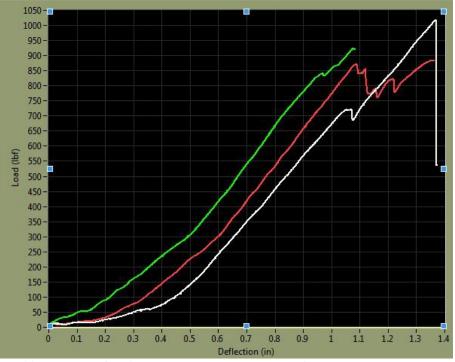
Photo 11: Load- Deflection Plot Lateral Load Test, SPF

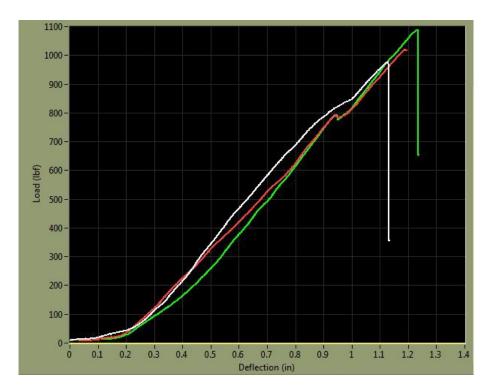
Photo 11: Load- Deflection Plot Lateral Load Test, SYP
