SCOPE OF WORK

REPORT NUMBER

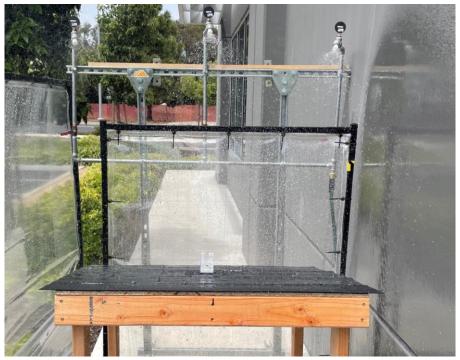
Photo No. 2 Test Specimen Under Test

TITLE OF TEST	RESULTS	ALLOWED	NOTE
Water Penetration,	Pass	No leakage	1, 2
Per UL 441 - One hour of water spray

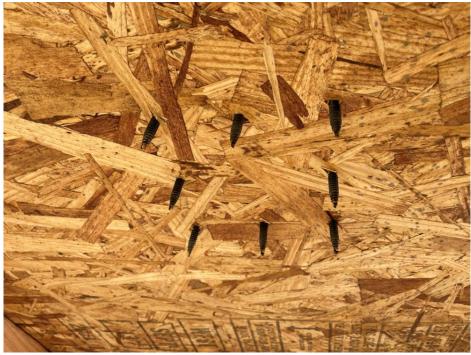
Photo No. 4
Underside of Test Desk After Test – no visible water penetration
