ESDEC, INC. TEST REPORT

UL 441 TESTING ON ECOFASTEN'S CORRUSLIDE MOUNT ROOF ATTACHMENT

105106865LAX-002

Subject: Project Summary of the Rain Testing per UL 441 on Ecofasten's Corruslide Mount

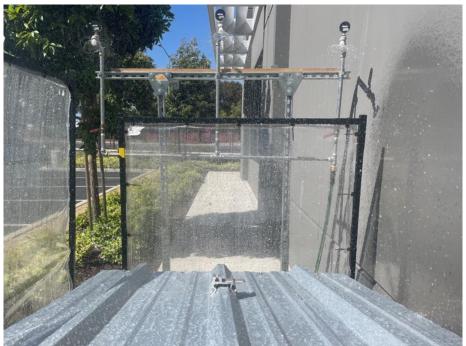
Photo No. 2 Test Specimen Under Test

The temperature during testing was 24°C (75°F) and the humidity was 42%. The results are tabulated as follows:

TITLE OF TEST	RESULTS	ALLOWED	NOTE
Water Penetration,	Pass	No leakage	1, 2
Per UL 441 - One hour of water spray

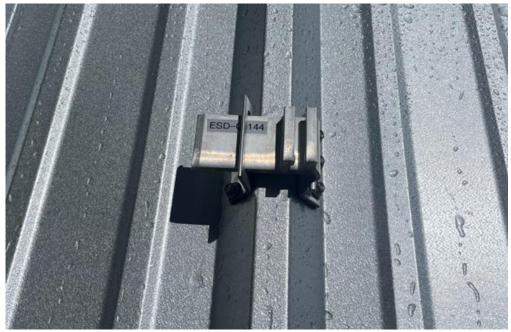
Photo No. 3 Test Specimen After Test

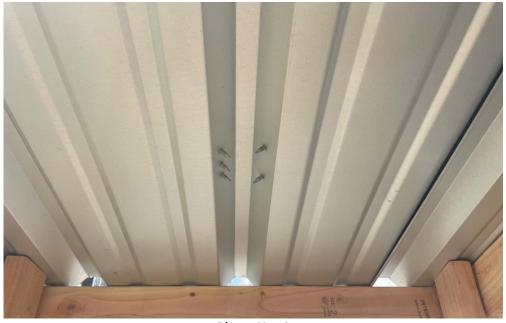
Photo No. 4
Underside of Test Desk After Test – no visible water penetration
