ESDEC, INC. MIAMI-DADE TEST REPORT

TAS 100 (A) TESTING ON ECOFASTEN JUNCTION BOX, SOLAR PHOTOVOLTAIC JUNCTION BOX

M9042.06-301-47

Report No.: M9042.06-301-47 R0

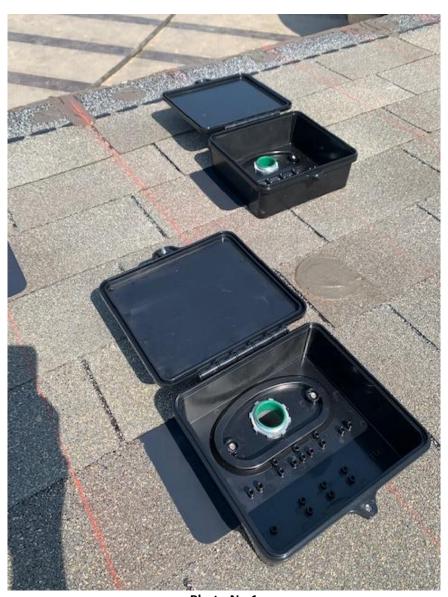
Photo No 1Top Side of the Test Deck Before Testing

Roof Deck Description: An 8'0" wide by 6'0" long roof deck on a 2:12 slope was utilized. The roof deck did not utilize a ridge vent. The roof deck consisted of #2 Spruce-Pine-Fir nominal 2x4 rafters sheathed with 7/16" Oriented Strand Board (OSB). The rafters were spaced 24" on center. The OSB was secured to the rafters with $48 \times 1-5/8$ " drywall screws spaced 6" on center around the perimeter and 12" on center at the intermediate supports. The OSB sheathing was covered with $48 \times 1-5/8$ " drywall screws spaced 6" on center around the perimeter and 12" on center at the intermediate supports.

Description/Installation (EcoFasten Junction Box): The test specimen was composed of a $12" \times 9" \times 0.035"$ thick aluminum flashing and a 9" wide by 8" long by 3" high Polymeric Junction box. The underside of the junction box has a pre-installed a 1/8" thick EPDM washer. The Junction box was secured with two #12" x 1.75" stainless steel screws with a bonded washer through the Junction box, flashing, and into the OSB sheathing of the test deck. The Junction box had 1-1/4" EMT connector and 1-1/4" EMT conduit section installed on the bottom of the enclosure that protruded through the deck. The Junction box was installed without sealant.

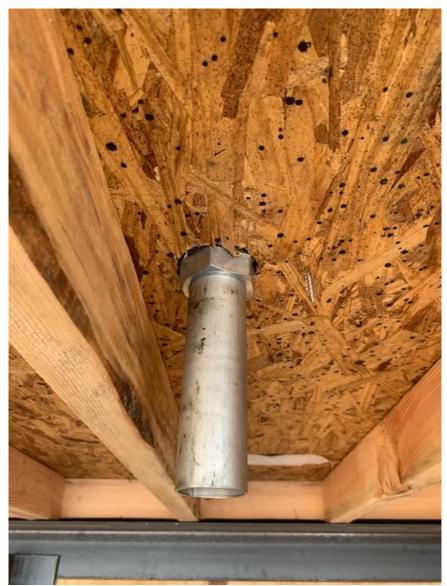
Photo No. 2 Underside of the Test Deck

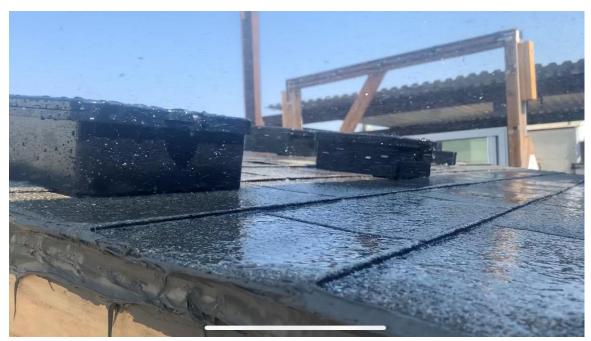
Photo No. 3 110 mph

Interval No.	Wind Speed (mph)	Time (min)	Water Spray
1	35	15	On
2	0	5	Off
3	70	15	On
4	0	5	Off
5	90	15	On
6	0	5	Off
7	110	5	On
8	0	5	Off

Wind Speed	Results
35 mph	0 oz.
70 mph	0 oz.
90 mph	0 oz.
110 mph	0 oz.

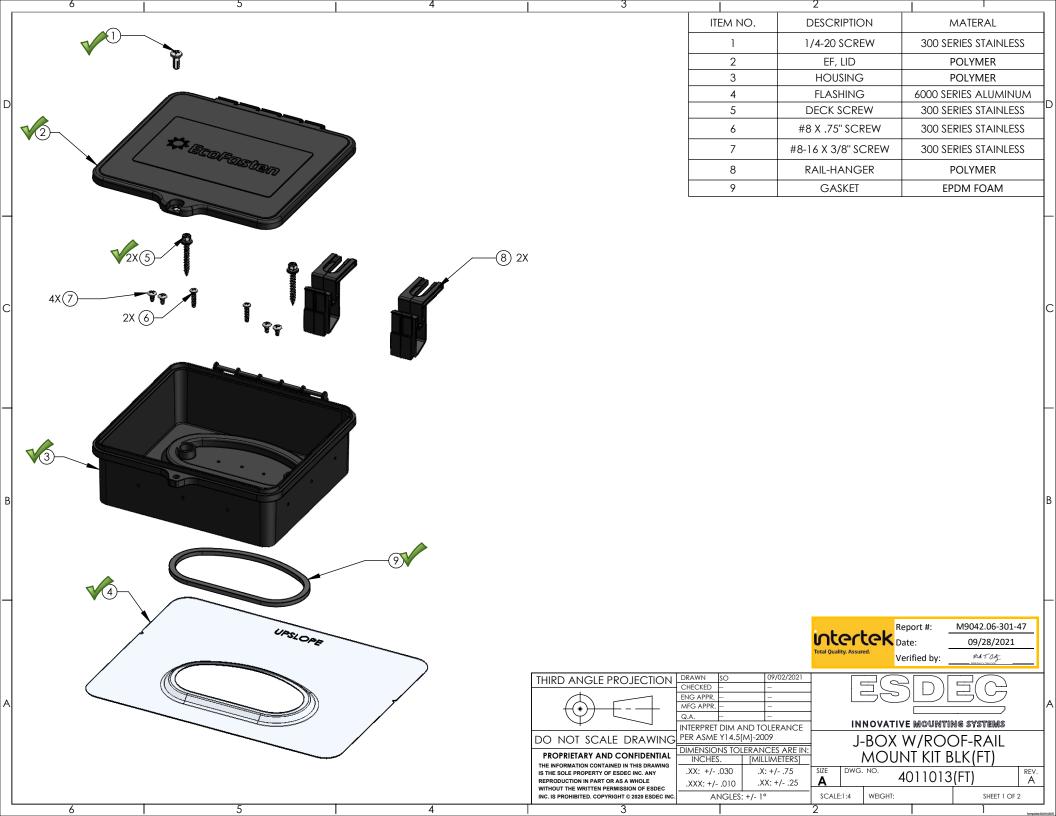
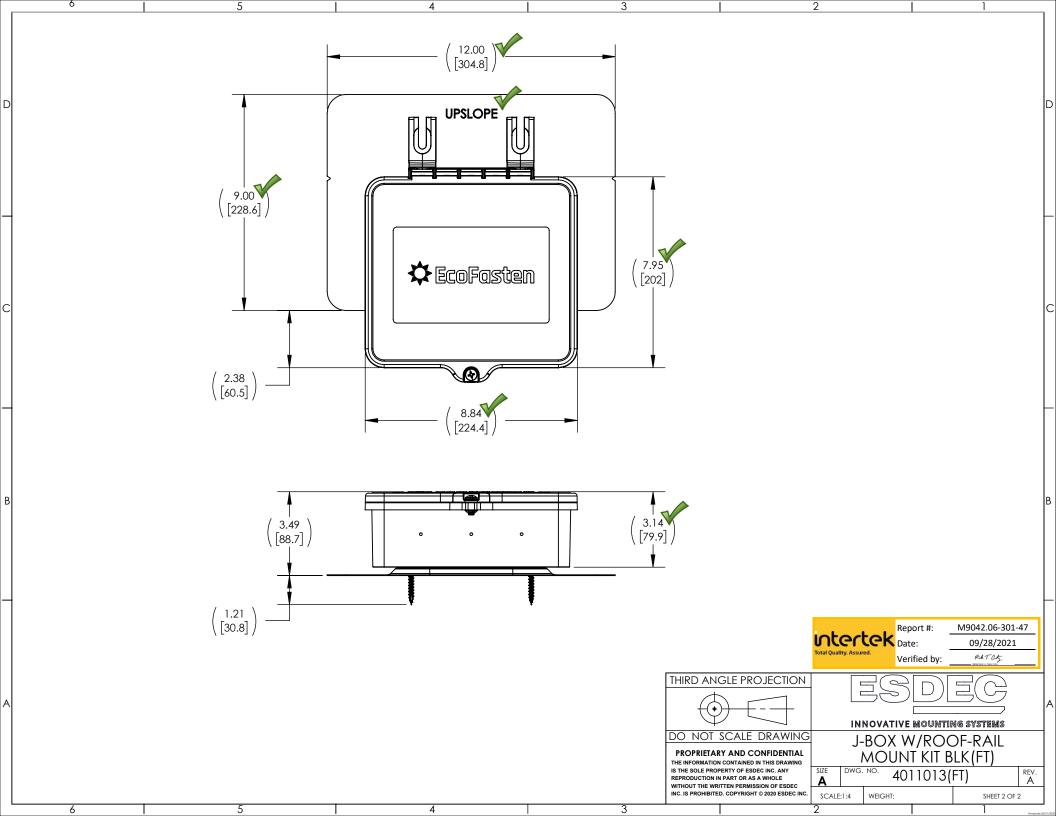
The test specimen drawings have been reviewed by Intertek B&C and are representative of the test specimen(s) reported herein. Test specimen construction was verified by Intertek B&C per the drawings included in this report. Any deviations are documented herein or on the drawings.
