ESDEC, INC. TEST REPORT

UL 441 TESTING ON ECOFASTEN'S SIM-SUPPORT ROOF ATTACHMENT

105106865LAX-005

Subject: Project Summary of the Rain Testing per UL 441 on Ecofasten's Sim-Support Roof

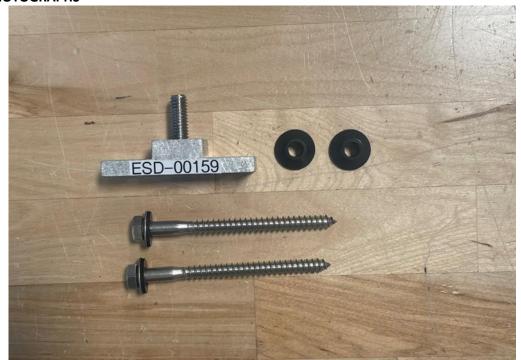
Photo No. 1 Unassembled Test Specimen

Description/Installation (Sim-Support Roof Attachment by Ecofasten): The test specimen was composed of two EPDM bushings installed into the 1"x 3" x 1.3" aluminum mount. Two 5/16"x4" lag screws with EPDM backed washers were used to secure the specimen into the center rafter through the metal panel. No sealant was used in the test.

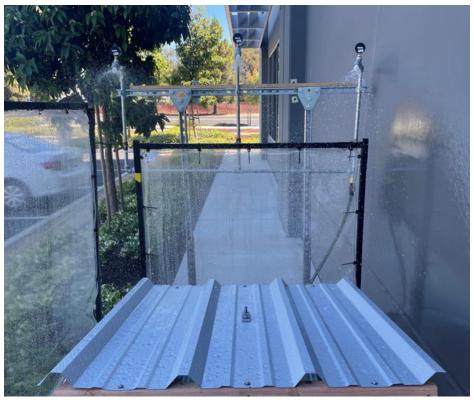
Photo No. 2 Test Specimen Under Test

TITLE OF TEST	RESULTS	ALLOWED	NOTE
Water Penetration,	Pass	No leakage	1, 2
Per UL 441 - One hour of water spray

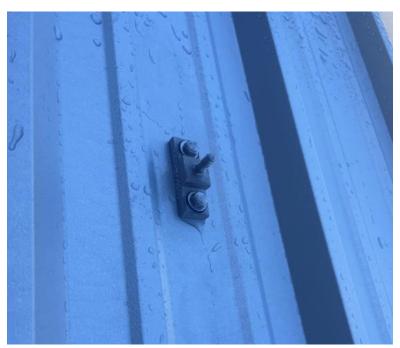
Photo No. 3
Test Specimen After Test

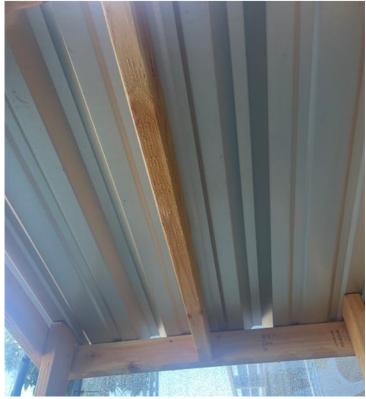
Photo No. 4
Underside of Test Desk After Test – no visible water penetration

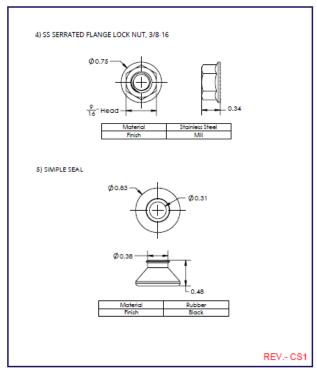
SIM-SUPPORT MOUNT AL

Drawing No. 1
Ecofasten Sim-Support Roof Attachment

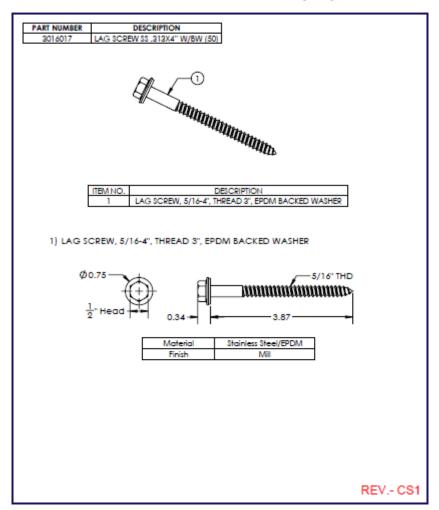
LAG SCREW SS .313X4" W/BW (50)

Drawing No. 2 Ecofasten Lag Screw
