# ESDEC, INC. TEST REPORT

UL 441 TESTING ON ECOFASTEN'S SIMPLESEAL ROOF ATTACHMENT

105106865LAX-004

**Subject:** Project Summary of the Rain Testing per UL 441 on Ecofasten's SimpleSeal Roof Attachment

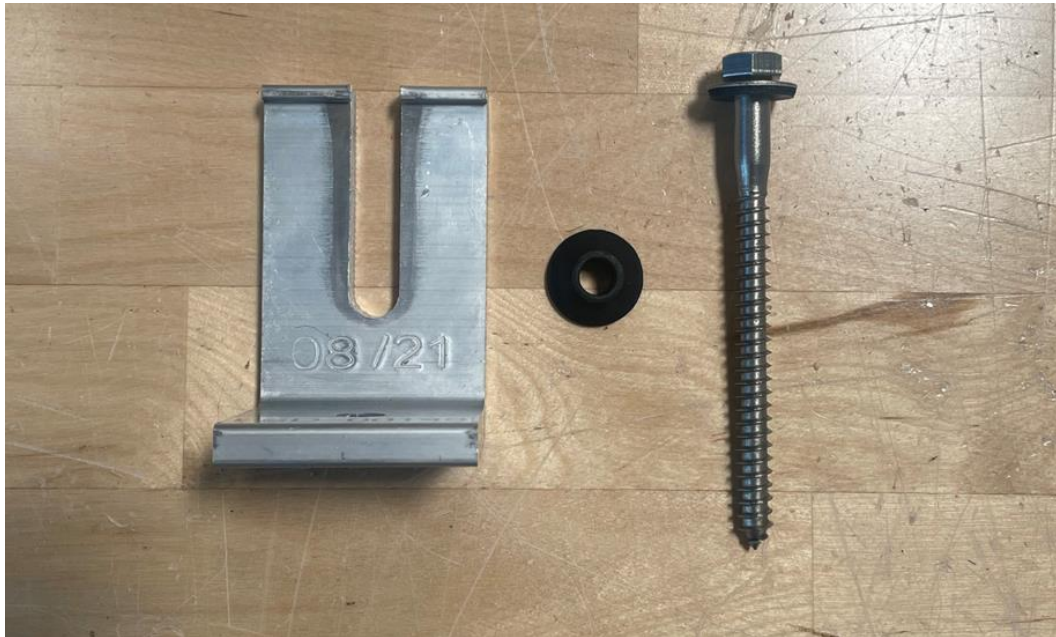
**Photo No. 1**  
**Unassembled Test Specimen**

**Description/Installation (SimpleSeal Roof Attachment by Ecofasten):** The test specimen was composed of an EPDM bushing installed into an approx. 3"x2"x2" aluminum L-foot. A 5/16" x 4" lag screw with EPDM backed washer was used to secure the specimen to the center rafter through the metal panel. No sealant was used in the test.

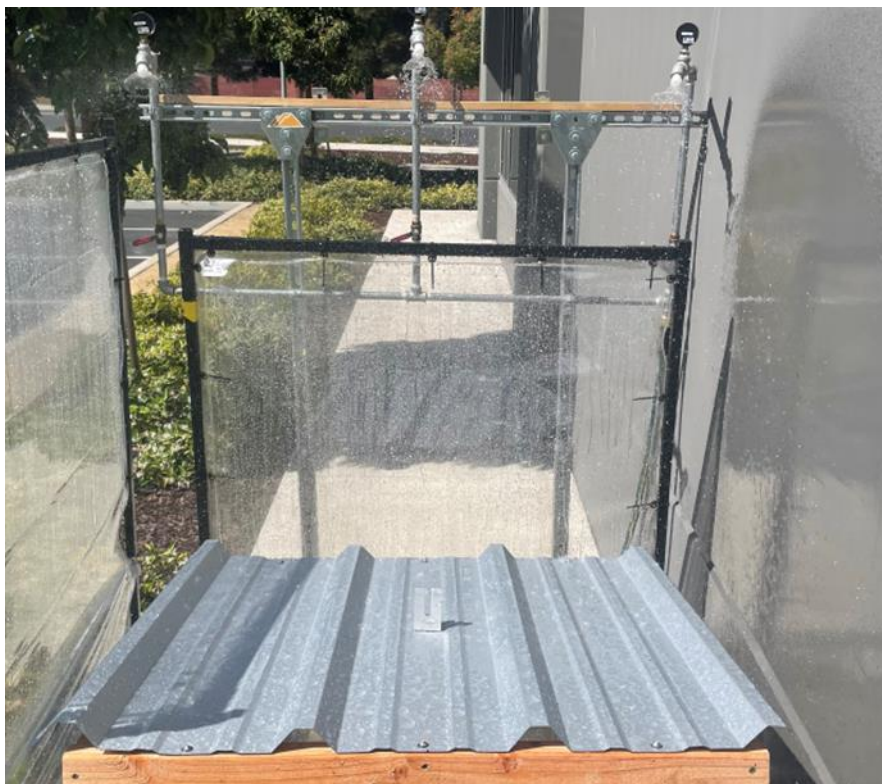
**Photo No. 2**  
**Test Specimen Under Test**

The specimen was installed onto a Spruce-Pine-Fir wood deck. The test deck measured 3' wide by 3' high and was constructed of #2 Spruce Pine Fir nominal 2x4 lumber. One rafter was centered on the deck for bolt attachment. The rafters were attached to the top and bottom plates with 3" long roofing screws. A 3' wide by 3' high sheet of 26ga PBR roof paneling was attached to the deck with #10-14 x 1" tapping screws with an EPDM bonded washer. The PBR panel was positioned such that its flat surface was centered flush with the rafter.

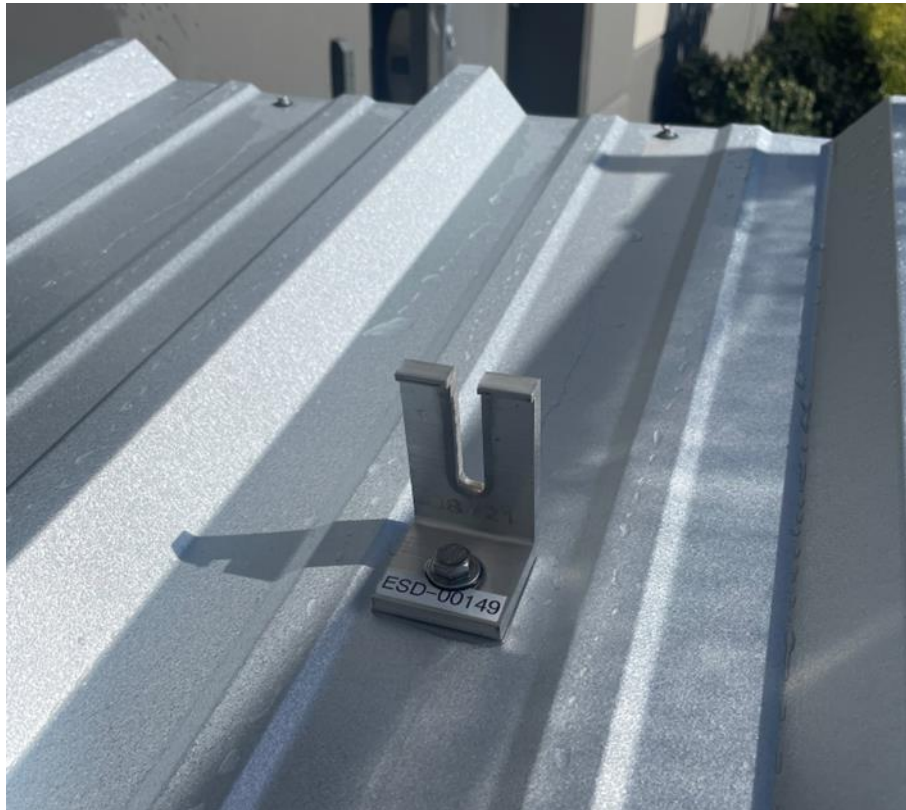
**Photo No. 3**  
**Test Specimen After Test**

TITLE OF TEST	RESULTS	ALLOWED	NOTE
Water Penetration, Per UL 441 - One hour of water spray	Pass	No leakage	1, 2

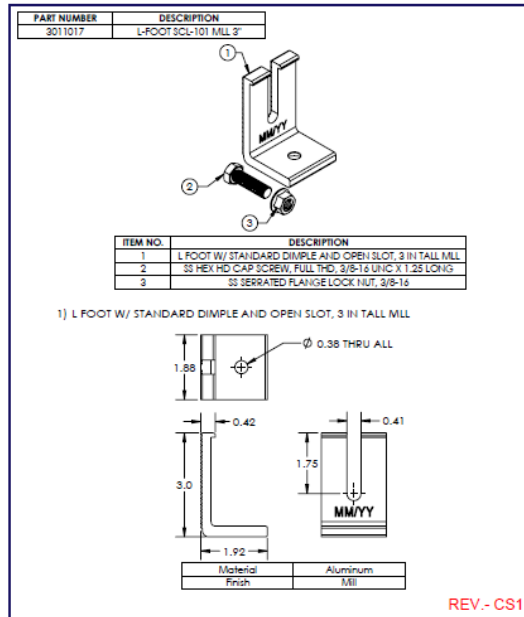
**Drawing No. 1**  
**Ecofasten SimpleSeal L-Foot**

#### L-FOOT SCL-101 MLL 3"

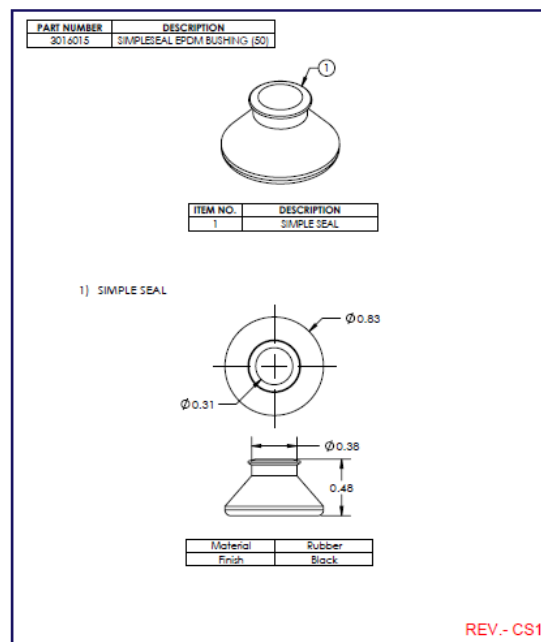
**Drawing No. 2**  
**Ecofasten SimpleSeal EPDM Bushing**

#### SIMPLESEAL EPDM BUSHING (50)

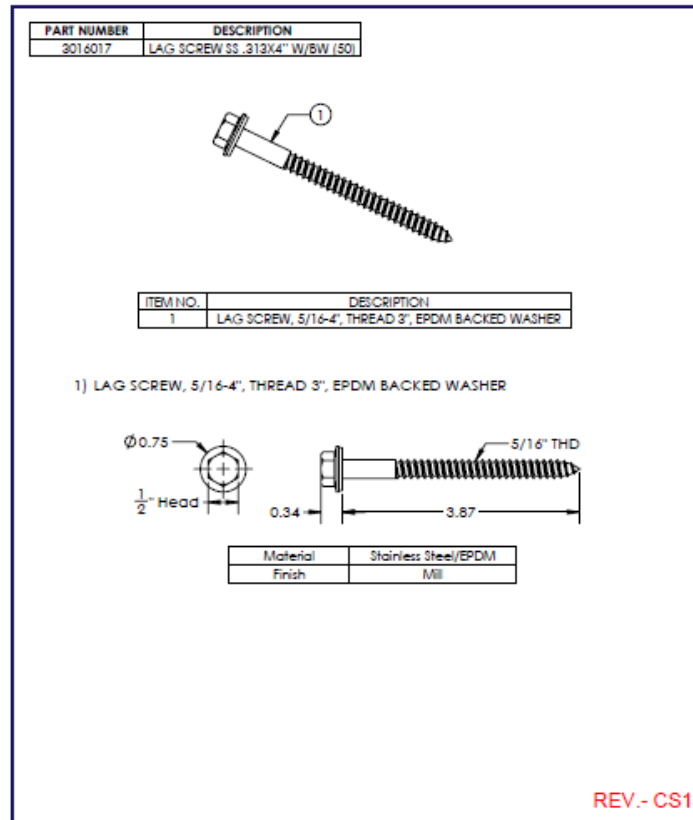
**Drawing No. 3**  
**Ecofasten SimpleSeal Lag Screw**

**LAG SCREW SS .313X4" W/BW (50)**
