TEST REPORT

TAS 100(A) TESTING ON ECOFASTEN CLICKFIT SMART FOOT, SOLAR PANEL ROOF ATTACHMENT

P2426.01-301-18 R0

TEST REPORT FOR ESDEC, INC.

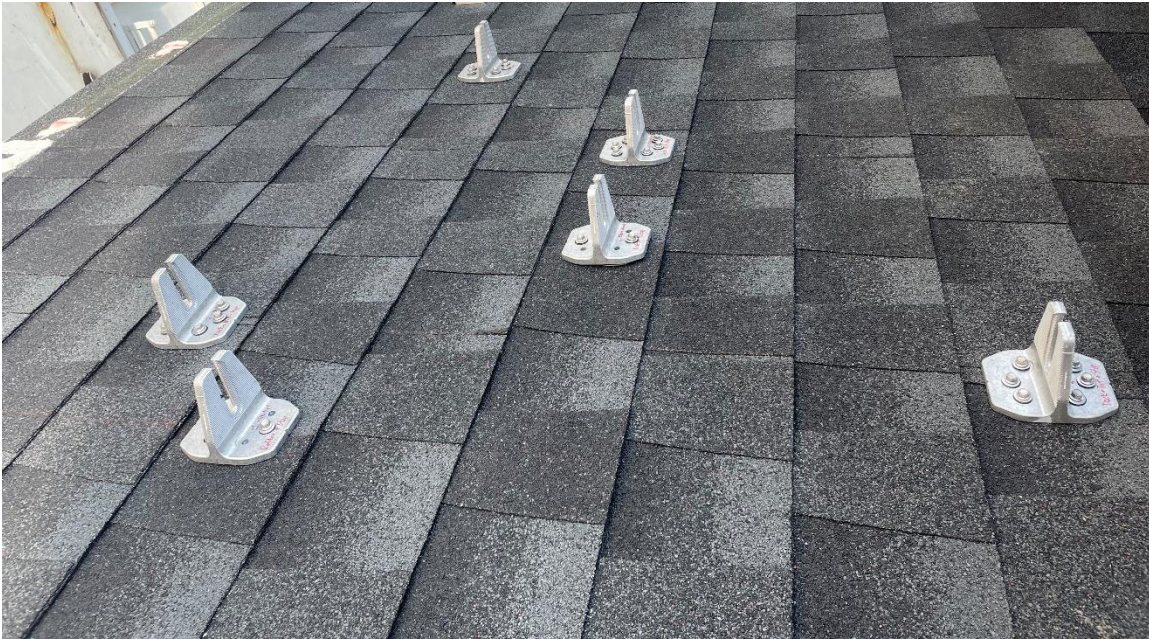
Photo No 1

Top Side of the Test Deck before Testing

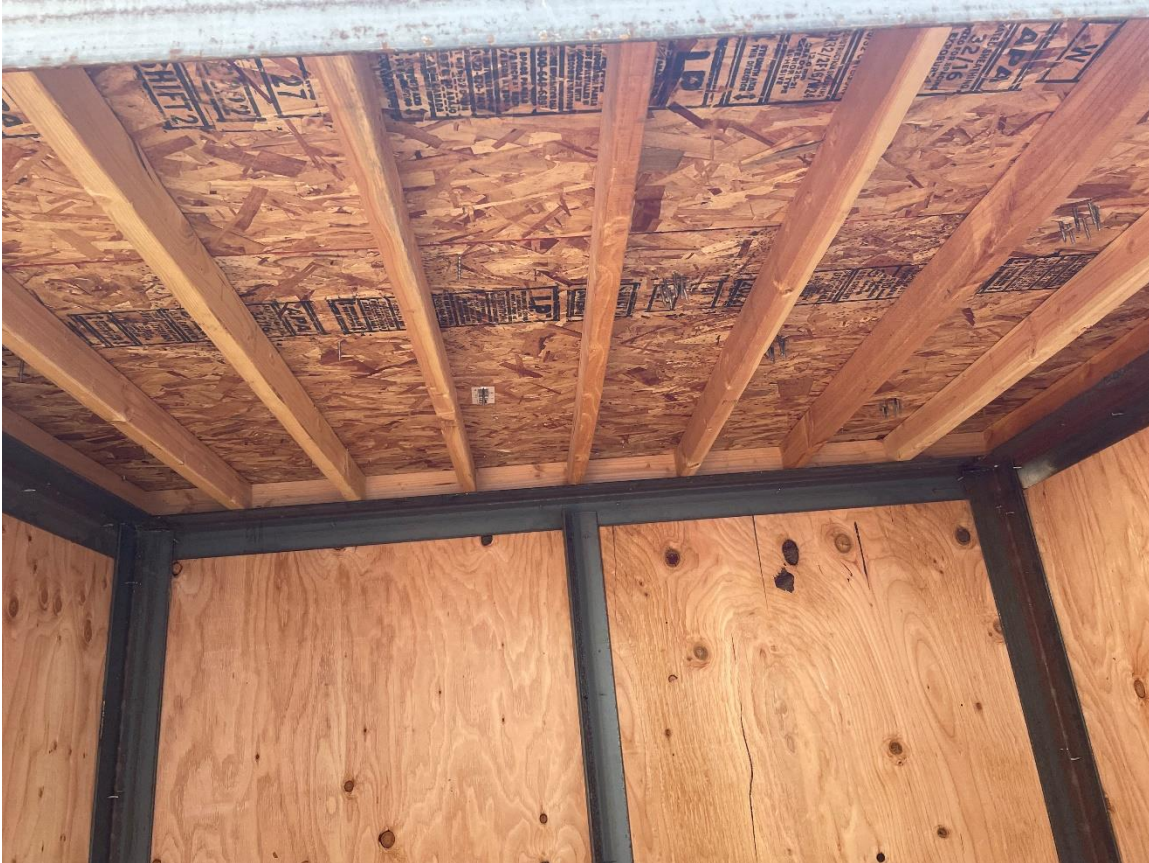
Photo No. 2

Underside of the Test Deck after Testing (no leaks)

Wind Speed	Results
35 mph	0 oz.
70 mph	0 oz.
90 mph	0 oz.
110 mph	0 oz.

Results: Pass

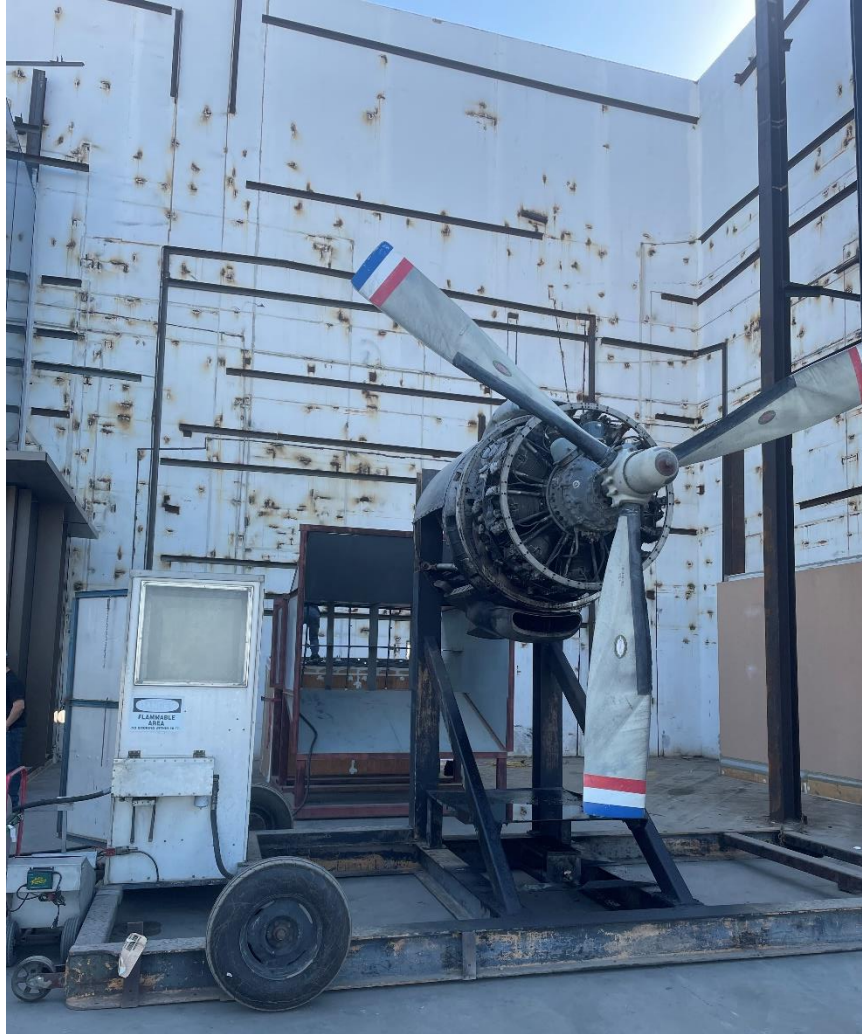
Photo No. 3

Test apparatus for TAS 100(A)

Interval No.	Wind Speed (mph)	Time (min)	Water Spray
1	35	15	On
2	0	5	Off
3	70	15	On
4	0	5	Off
5	90	15	On
6	0	5	Off
7	110	15	On
8	0	5	Off

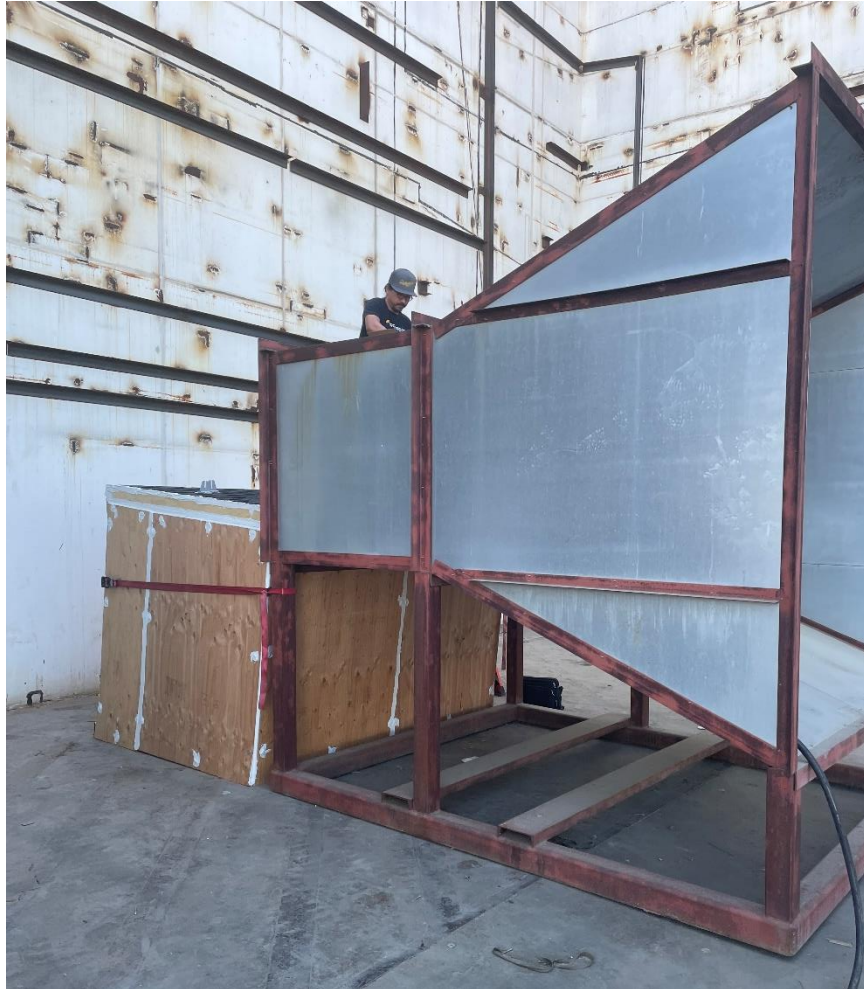
Photo No. 4

Test specimens loaded for TAS 100(A)

Note 2: *Six specimens were installed onto the test deck.*

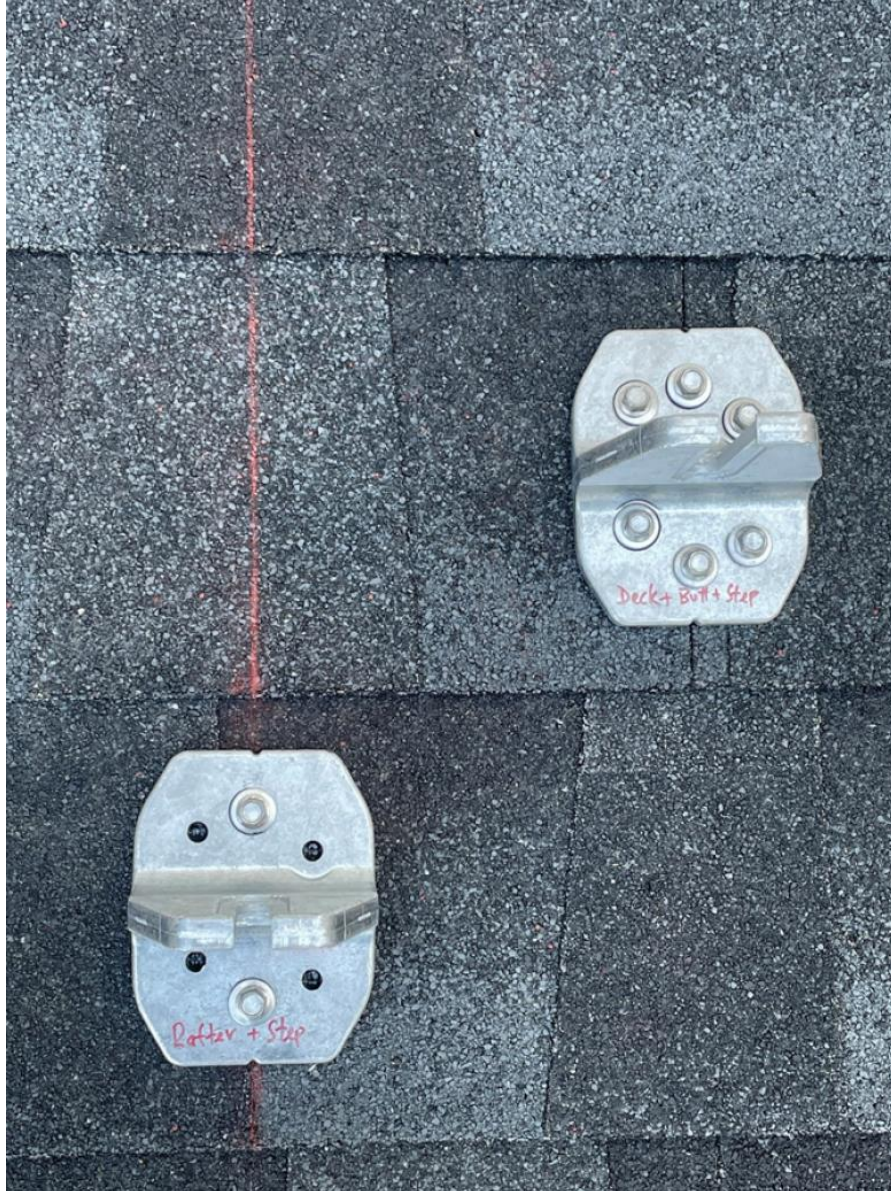
Photo No 5

Two conditions shown:

- Left – Installed onto Rafter with two structural wood screws (positioned over shingle step)
- Right – Installed onto Deck with six structural wood screws (positioned over shingle butt joint & step)

Description/Installation (EcoFasten ClickFit SMART FOOT): The test specimen was composed of a die-cast aluminum roof attachment approximately 3" x 3-3/4" x 3-1/2" tall with a flashing system using either a gray or black sealant. The roof attachment was fastened to the test deck with #14x3" stainless steel structural wood screws with EPDM backed stainless steel washers. Two (2) structural wood screws were used when installing directly into rafters. Six (6) structural wood screws were used when installing directly into the deck. No pilot holes were drilled.

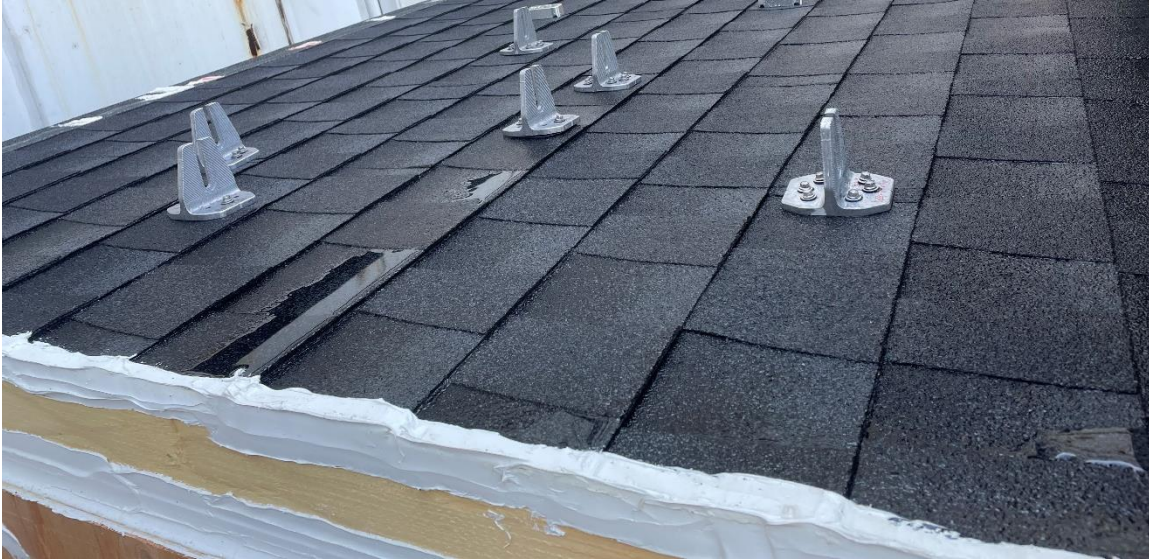
Photo No 6

Top Side of the Test Deck After Testing

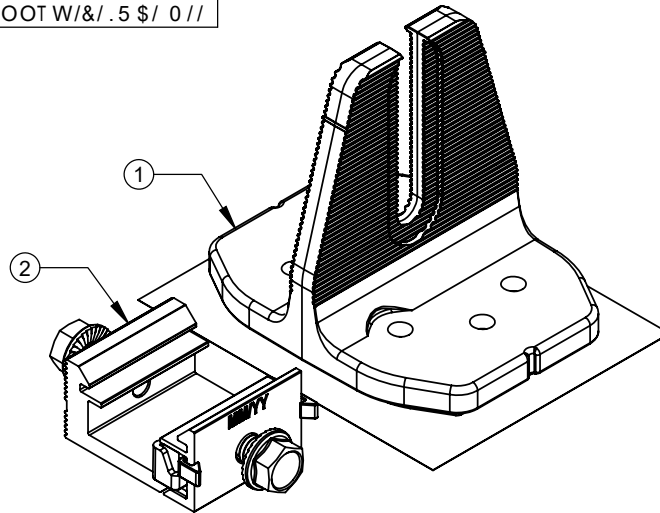
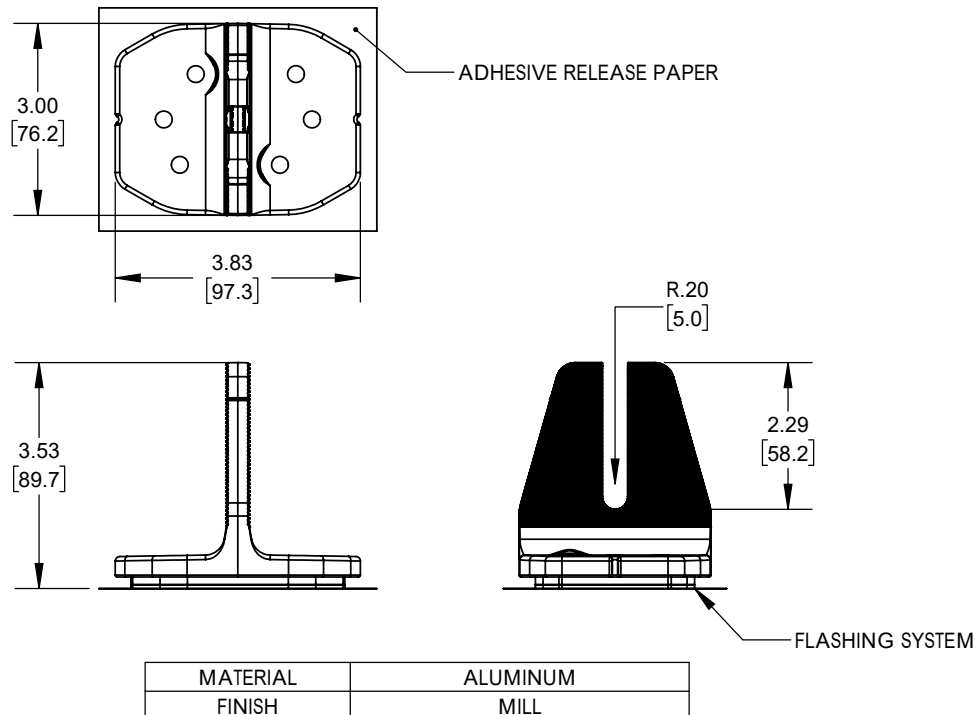
CF SMART FOOT W/CLKR AL MLL

ITEM NO.	DESCRIPTION
1	CLICKFIT SMARTFOOT
2	CLICKFIT RAIL ATTACHMENT ASSY W/MNT BOLT

1) CLICKFIT SMARTFOOT

2) CLICKFIT RAIL ATTACHMENT ASSY W/MNT BOLT

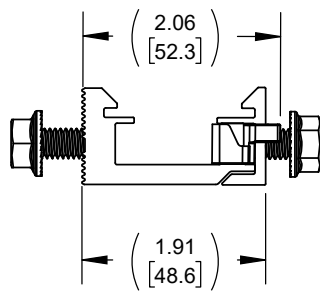
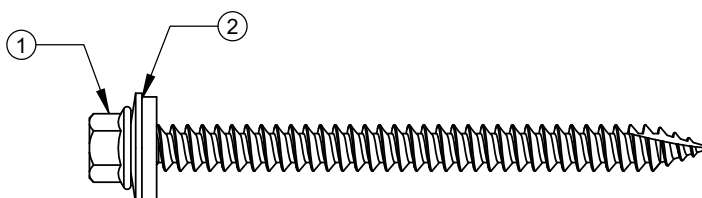
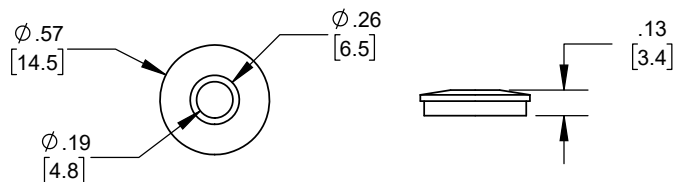
SCREW #14X3" W/BW

ITEM NO.	DESCRIPTION
1	STRUCTURAL WOOD SCREW, #14X3"
2	WASHER, SEALING, EPDM BACKED STAINLESS STEEL

1) STRUCTURAL WOOD SCREW, #14X3"

2) WASHER, SEALING, EPDM BACKED STAINLESS STEEL

MATERIAL	STAINLESS STEEL, EPDM
FINISH	MILL
