ESDEC, INC. TEST REPORT

UL 441 TESTING ON ECOFASTEN'S TR-MOUNT

105106865LAX-003

Subject: Project Summary of the Rain Testing per UL 441 on Ecofasten's TR-Mount

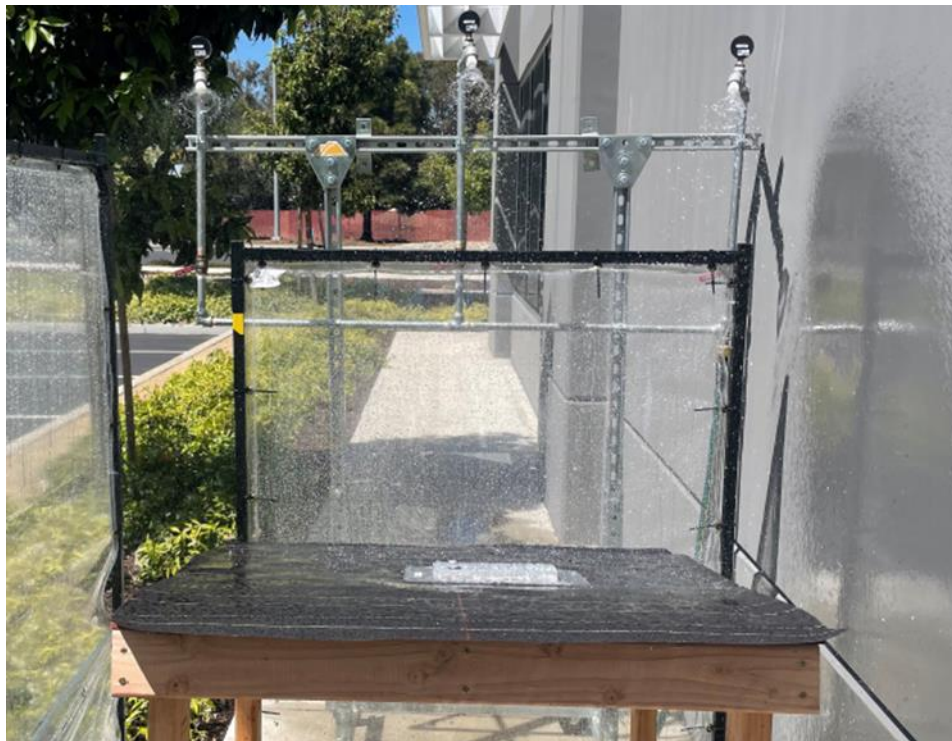
Photo No. 2
Test Specimen Under Test

TITLE OF TEST	RESULTS	ALLOWED	NOTE
Water Penetration, Per UL 441 - One hour of water spray	Pass	No leakage	1, 2

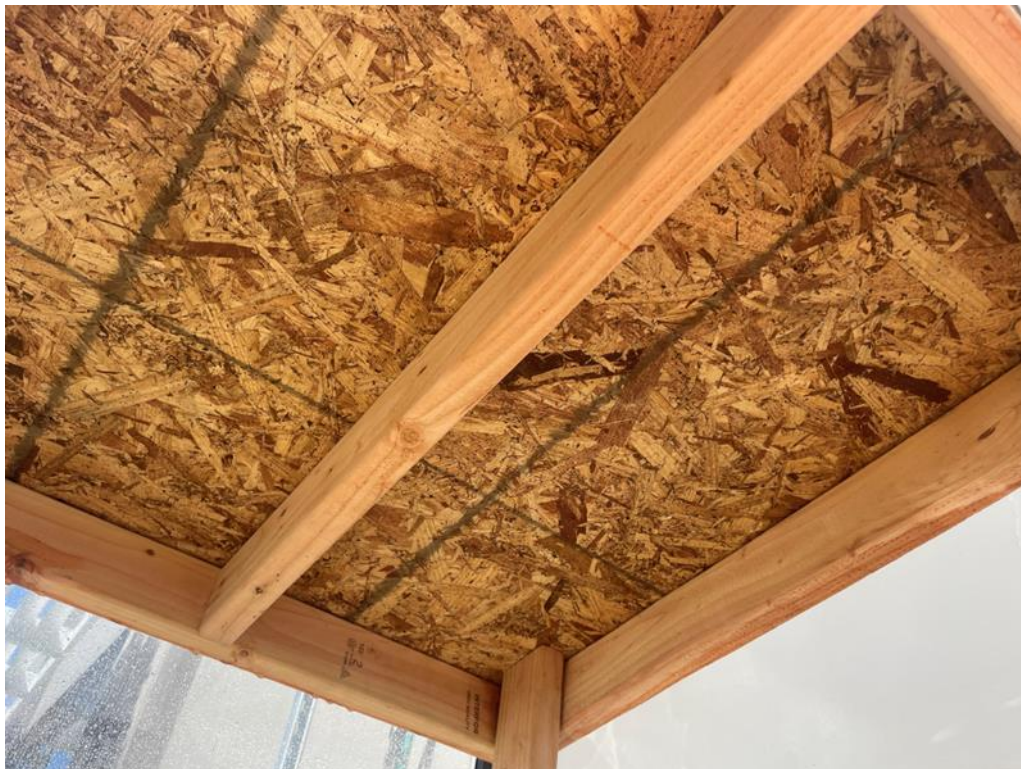
Photo No. 4
Underside of Test Desk After Test – no visible water penetration
