# ESDEC, INC. TEST REPORT

UL 441 TESTING ON ECOFASTEN'S GF1

104500499LAX-001

**Subject:** Project Summary of the Rain Testing per UL 441 on Ecofasten's GF1

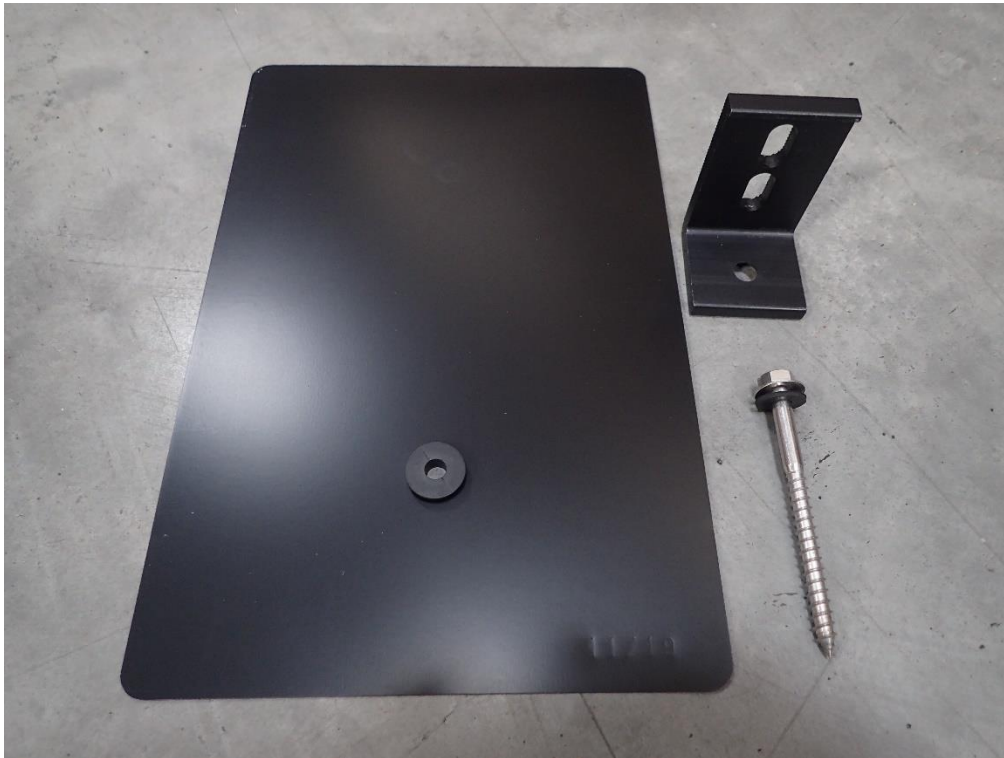
**Photo No. 1**

**Unassembled Test Specimen (including 1 lag screw, 1 flashing, and 1 aluminium L-foot)**

**Description/Installation (GF1 by Ecofasten):** The test specimen was composed of an 8" x 12" x 0.03125" thick galvalume flashing and a 1-7/8" wide by 3" high extruded aluminum L-foot. The underside of the L-foot was secured with one 5/16"x 4" lag screw with a EPDM backed washer through the L-foot, flashing and into the center rafter of the test deck. The GF1 assembly was installed without sealant.

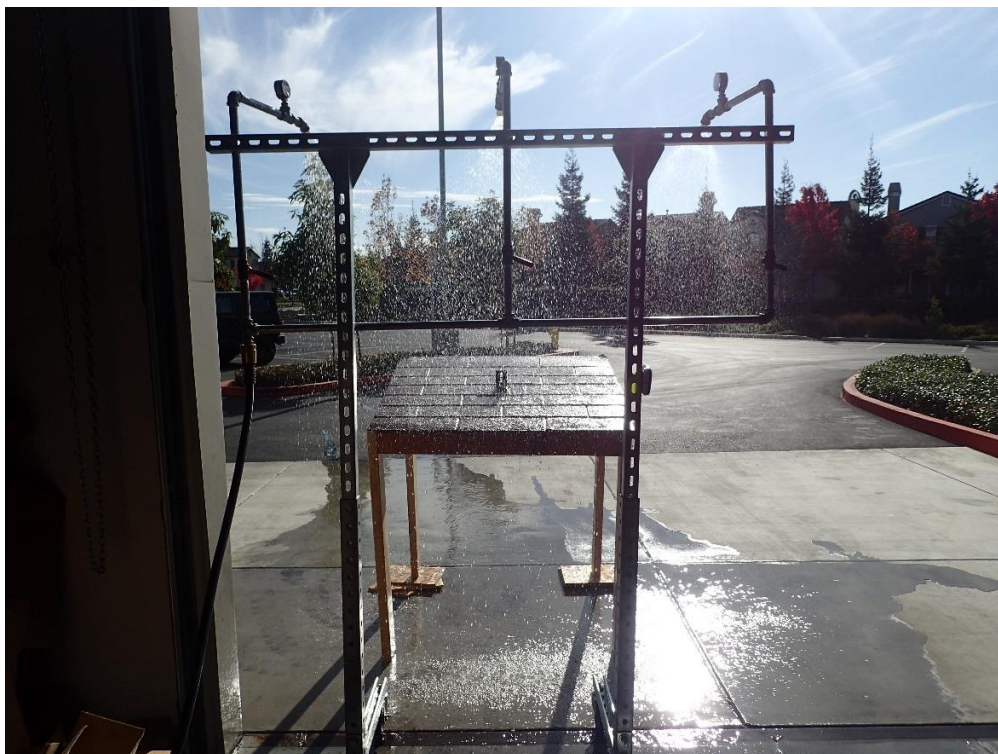
**Photo No. 2**

**Test Specimen Under Test**

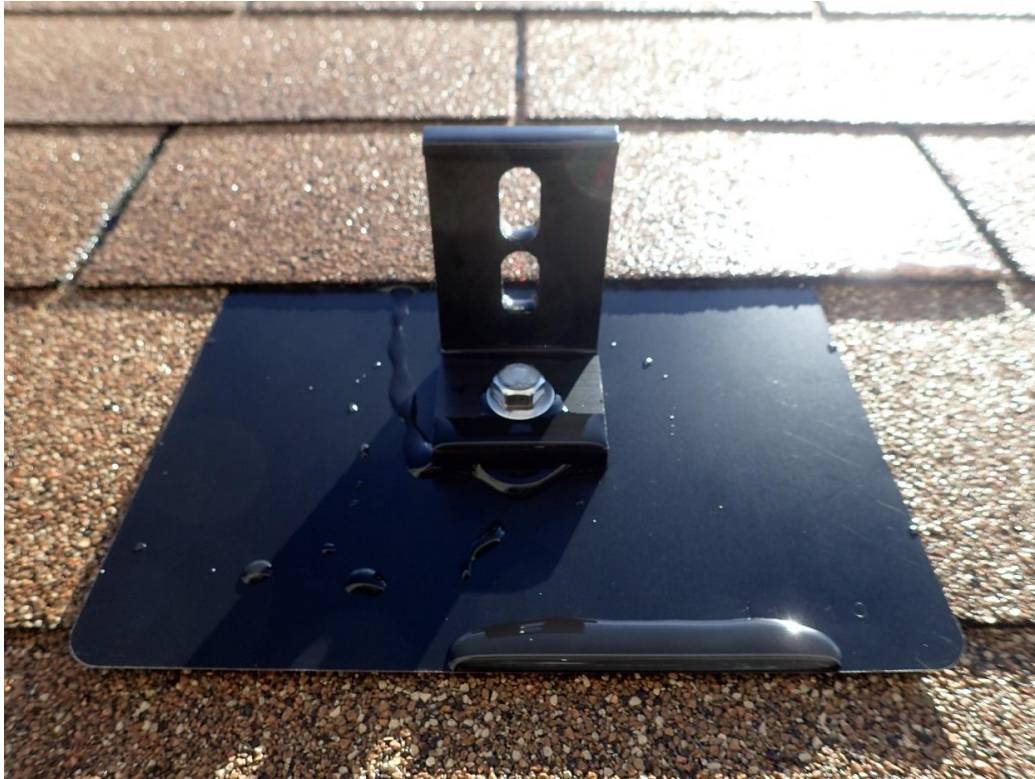
**Photo No. 3**  
**Test Specimen After Test**

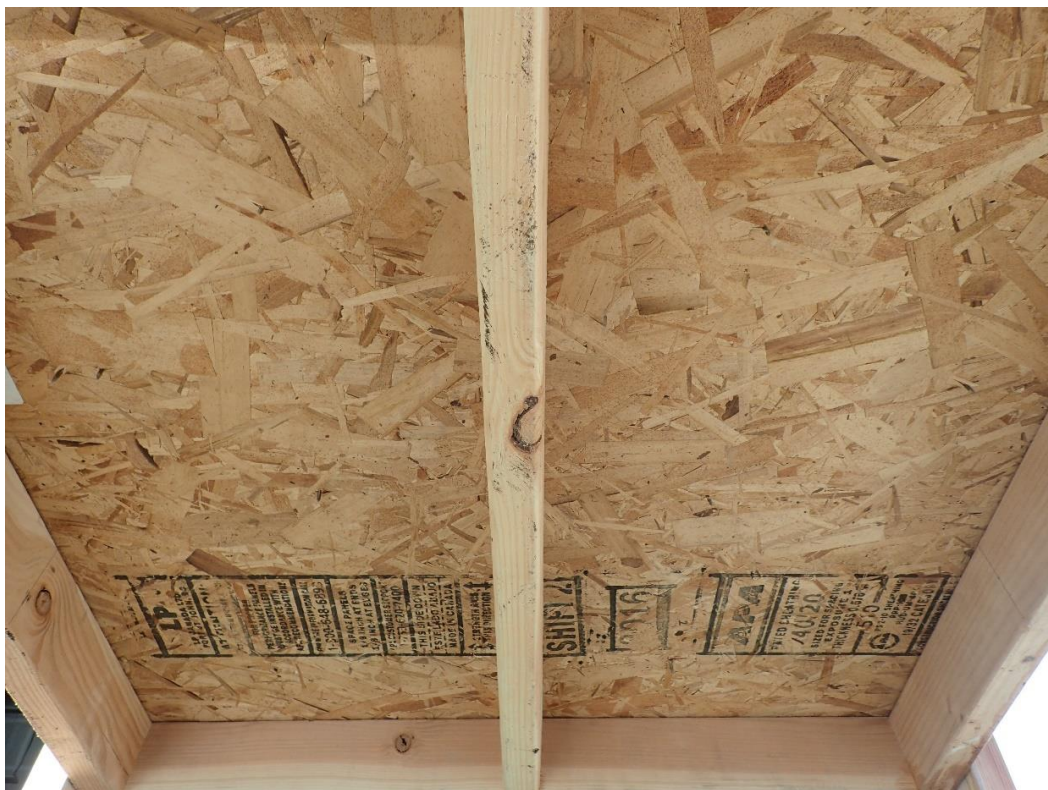
**Photo No. 4**  
**Underside of Test Desk After Test – no visible water penetration**

TITLE OF TEST	RESULTS	ALLOWED	NOTE
Water Penetration, Per UL 441 - One hour of water spray	Pass	No leakage	1, 2, 3

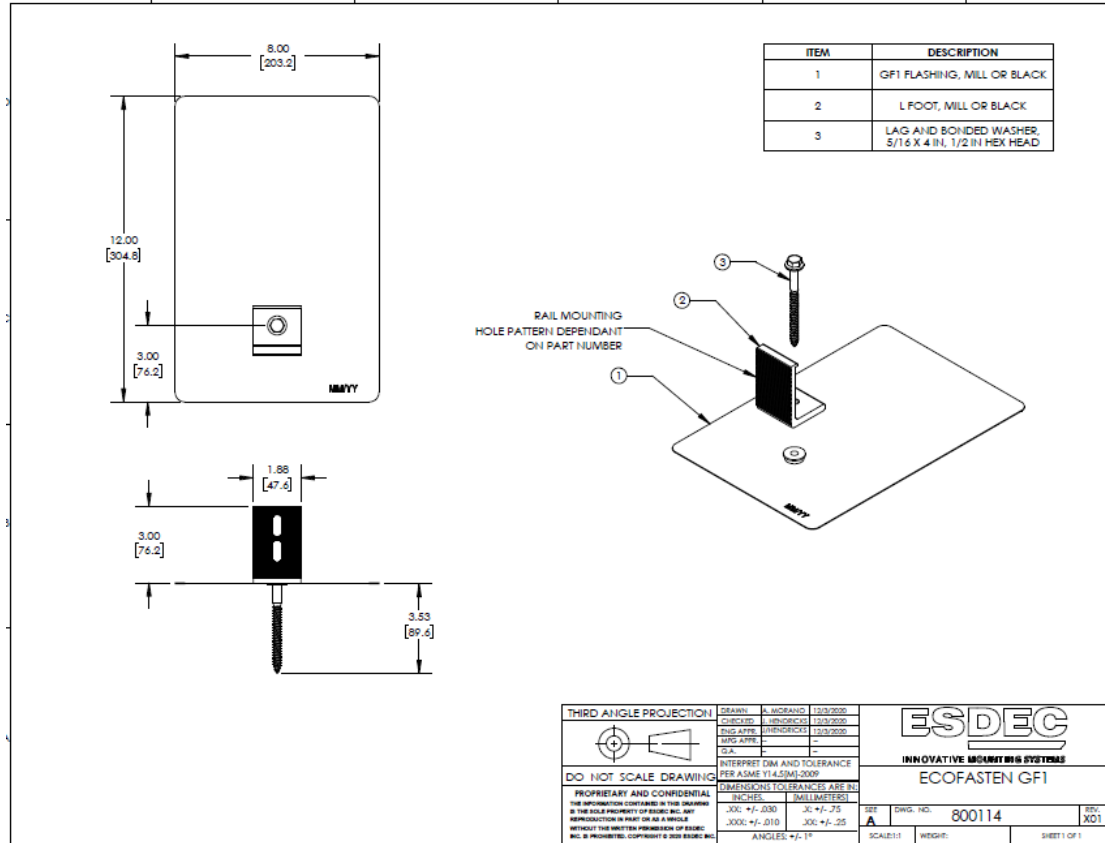
**Drawing No. 1**  
**Ecofasten's GF1**

The test specimen drawings have been reviewed by Intertek and are representative of the test specimen(s) reported herein. Any deviations are documented herein or on the drawings.
