# ESDEC, INC. TEST REPORT

UL 441 TESTING ON ECOFASTEN JUNCTION BOX

104779499LAX-004

**Subject:** Project Summary of the Rain Testing per UL 441 on ECOFASTEN's Junction Box

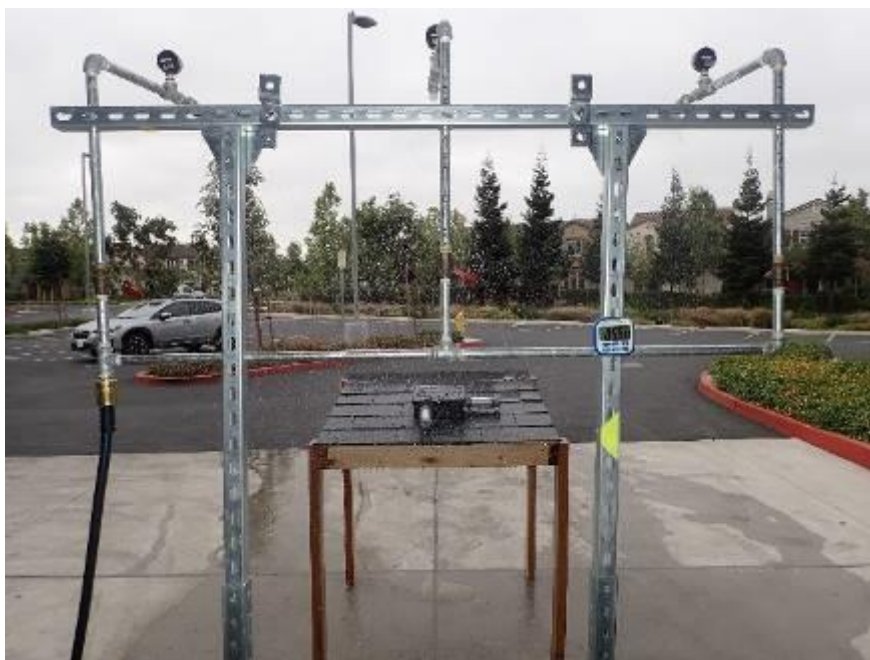
**Photo No. 4**  
**Test Specimen Under Test**

The specimen was installed onto a Spruce-Pine-Fir wood deck. The test deck measured 3' wide by 3' high and was constructed of #2 Spruce Pine Fir nominal 2x4 lumber. No center rafter was used in test deck since test specimen was tested in a deck mount only configuration. Test specimen was mounted to center of test deck. A sheet of nominal 7/16" thick plywood was secured to the studs with #8 x 1-5/8" roofing screws. The test deck was then covered with #15 felt paper and three-tab asphalt shingles.

TITLE OF TEST	RESULTS	ALLOWED	NOTE
Water Penetration, Per UL 441 - One hour of water spray	Pass	No leakage	1, 2

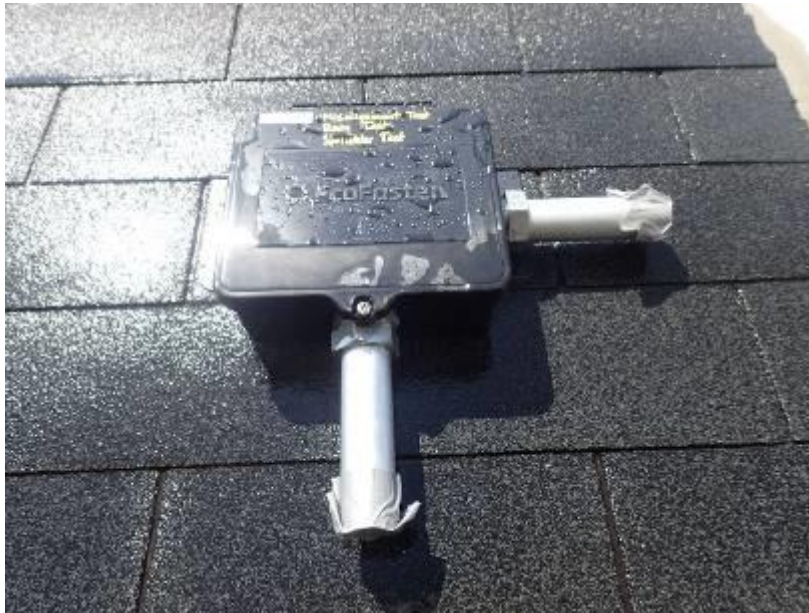
**Photo No. 5**  
**Test Specimen After Test**

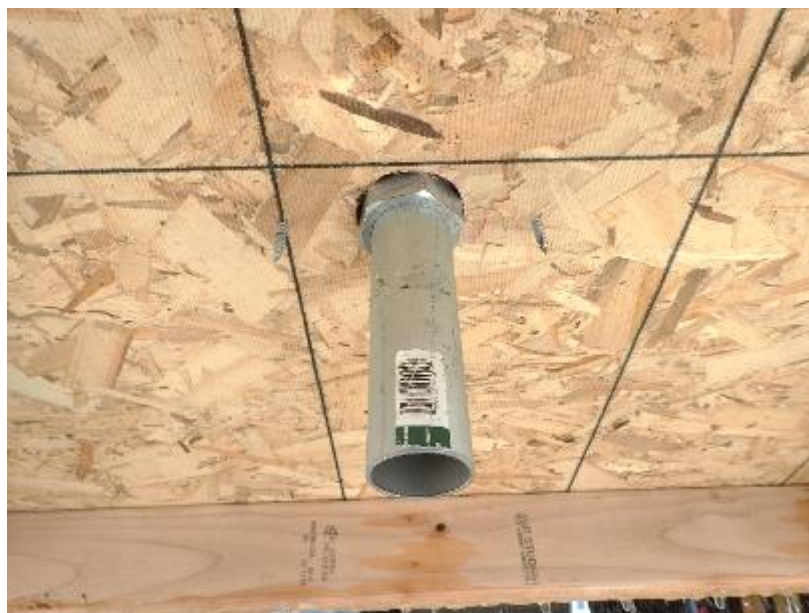
**Photo No. 6**  
**Underside of Test Desk After Test – no visible water penetration**

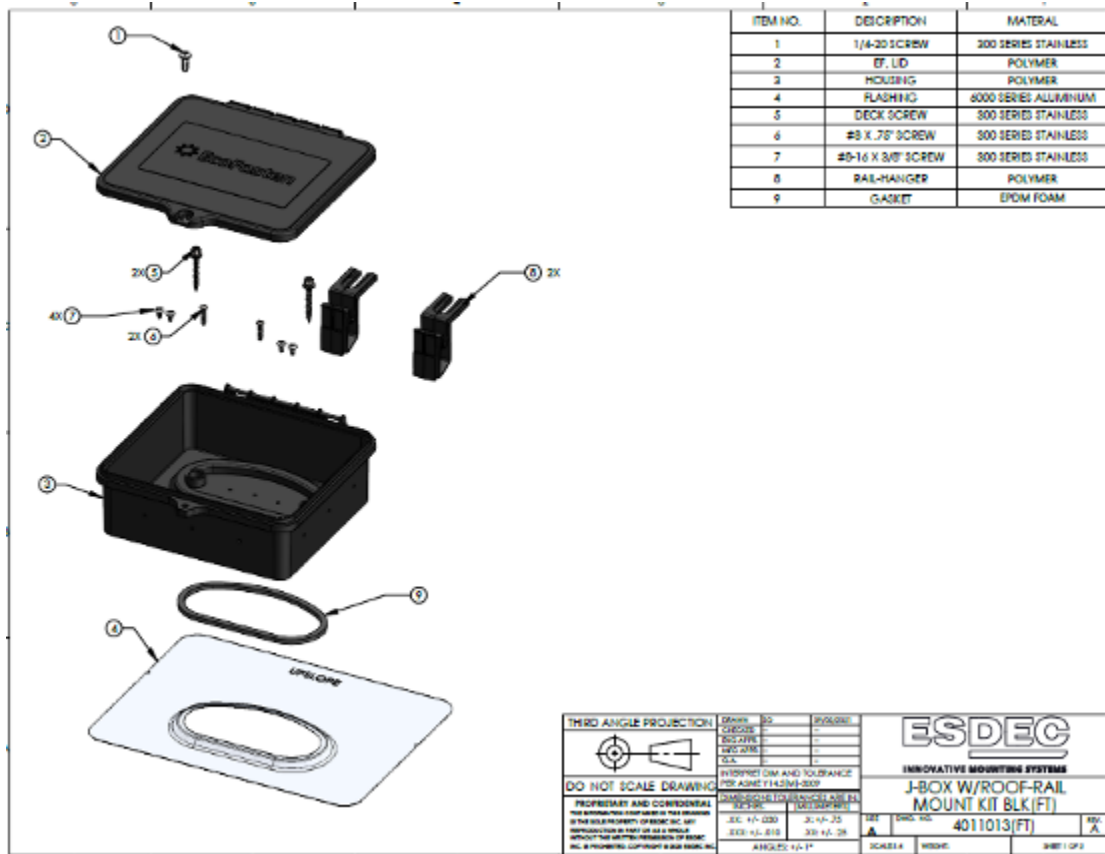
**Drawing No. 1  
Assembly Drawing**

The test specimen drawings have been reviewed by Intertek and are representative of the test specimen(s) reported herein. Any deviations are documented herein or on the drawings.

**Description/Installation (Ecofasten Junction Box):** The test specimen was composed of a polymeric enclosure 8" x 9" x 3" with an EPDM Foam gasket in rear of enclosure and 9"x12"x0.032" thick aluminum flashing. The enclosure was secured with Qty 2 - #12 - 1-3/4" deck screws with EPDM bonded washers through the enclosure interior and flashing and into the center of the test deck. The enclosure was also installed with Qty 3 - 1-1/4" conduit hubs with 1-1/4"x6" conduit. Lid was secured prior to testing.
