Project Number: A0004-0003-171

EcoFasten Solar 4741 W. Polk St., Suite 4 Phoenix, AZ 58043

REFERENCE: Simple Block Ultimate Capacity Laboratory Test Results

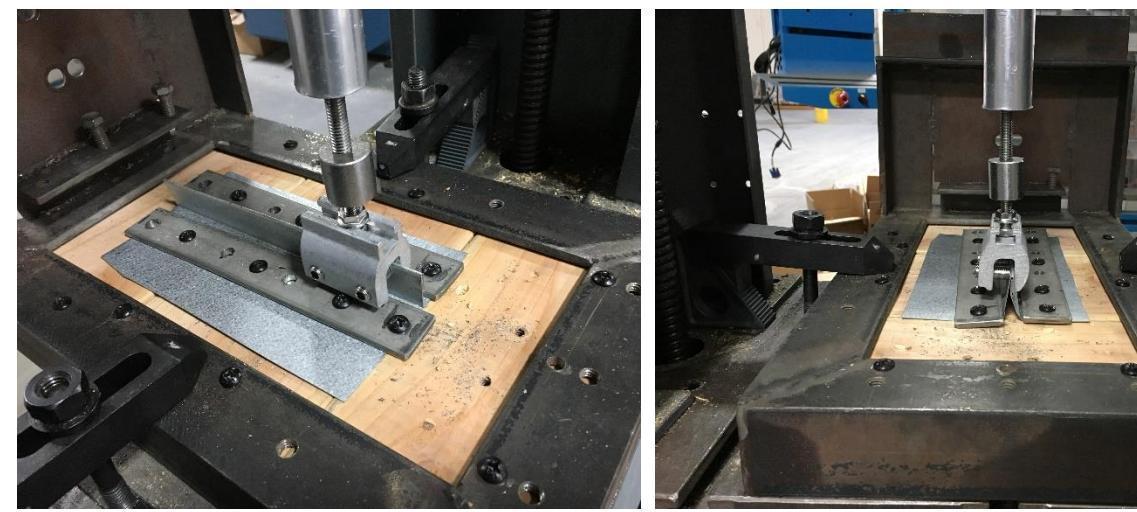
Figure 1

- Simple Block
 - Approximate overall dimensions = 1-11/16" (H) x 2" (L) x 1-5/16" (W)
 - \circ Material = 6000 series aluminum extrusion
 - Two 3/8" Dia. ball nosed set screws spaced at approx. 1 1/4"
 - See attached assembly sheet on page 5 for additional information
- Standing Metal Seam Specimens
 - Material = 26ga ACRYLUME (acrylic coated galvanized steel)
 - Approximate seam height and type = 1" double-lock
 - The seam was isolated by using aluminum plates and screws to fasten the plates and standing seam material to a solid wood base material. Refer to Figure 1.

- Simple Block Uplift Test- The Simple Block was fastened to the metal seam with the lip of the Simple Block oriented to be able to engage the underside of the double-lock seam. The set-screws were tightened to 150 in/lbs. using a torque wrench. Then a hex head bolt was inserted into the channel on top of the Simple Block that was then attached to the load cell and loading mechanism which applied load perpendicular to the seam. Refer to Figure 1, Figure 2, and Page 5.

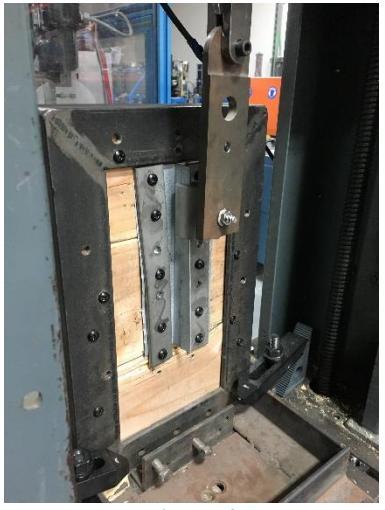
- Simple Block Shear Test- The Simple Block was fastened to the metal seam with the lip of the Simple Block oriented to be able to engage the underside of the double-lock seam. The set-screws were tightened to 150 in/lbs. using a torque wrench. Then a hex head bolt was inserted into the channel on top of the Simple Block. That bolt was attached to a plate that was then connected to the load cell and loading mechanism which applied load parallel to the seam. Refer to Figure 3 and Page 5.

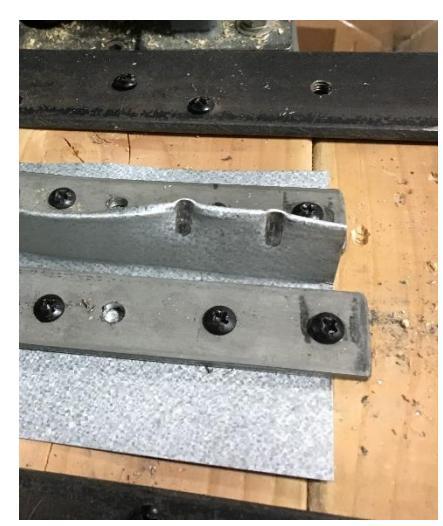
Figure 5

- Observations = The metal seam deformed during the loading prior to the final failure mode noted 0 above, but the set screws did not tear or puncture the standing metal seam. Refer to Figures 5 & 6.

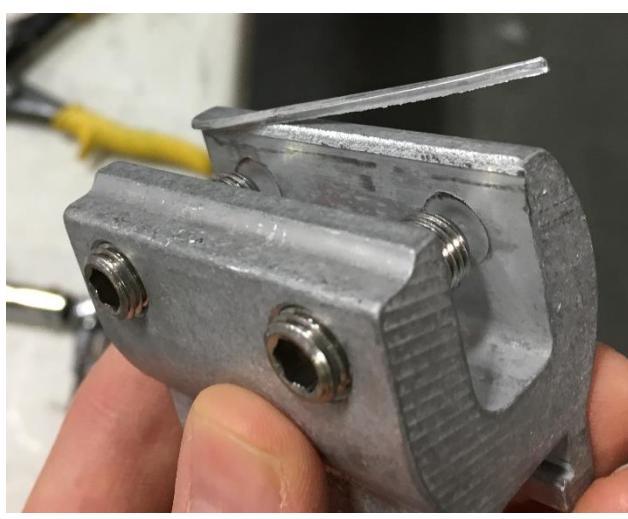
Figure 4

- Simple Block Uplift Test (26ga ACRYLUME 1" double-lock standing metal seam)
 - Average Ultimate Load = 1,980 lb. (Static Load) 0
 - Failure Mode = The small lip of the simple block that fits underneath the standing metal seam 0 began to peel off. Refer to Figure 4.

- Simple Block Shear Test (26ga ACRYLUME 1" double-lock standing metal seam)
 - Average Ultimate Load = 1.030 lb. (Static Load) 0
 - Failure Modes = The metal seam buckled and/or the small lip of the simple block that fits 0 underneath the standing metal seam began to peel off. Refer to Figures 4 & 7.

- Observations = The metal seam deformed significantly during the loading and in prior to the lip of 0 the simple block beginning to peel off. The set screws did not tear or puncture the standing metal seam. Refer to Figures 4 & 7. Some bending of the bolt and some damage in the Simple Block around the bolt head was also evident in some tests.
