Re: EcoFasten 44-R Roof Deck Attachment Capacities

APPENDIX A: ENGINEERING DRAWING

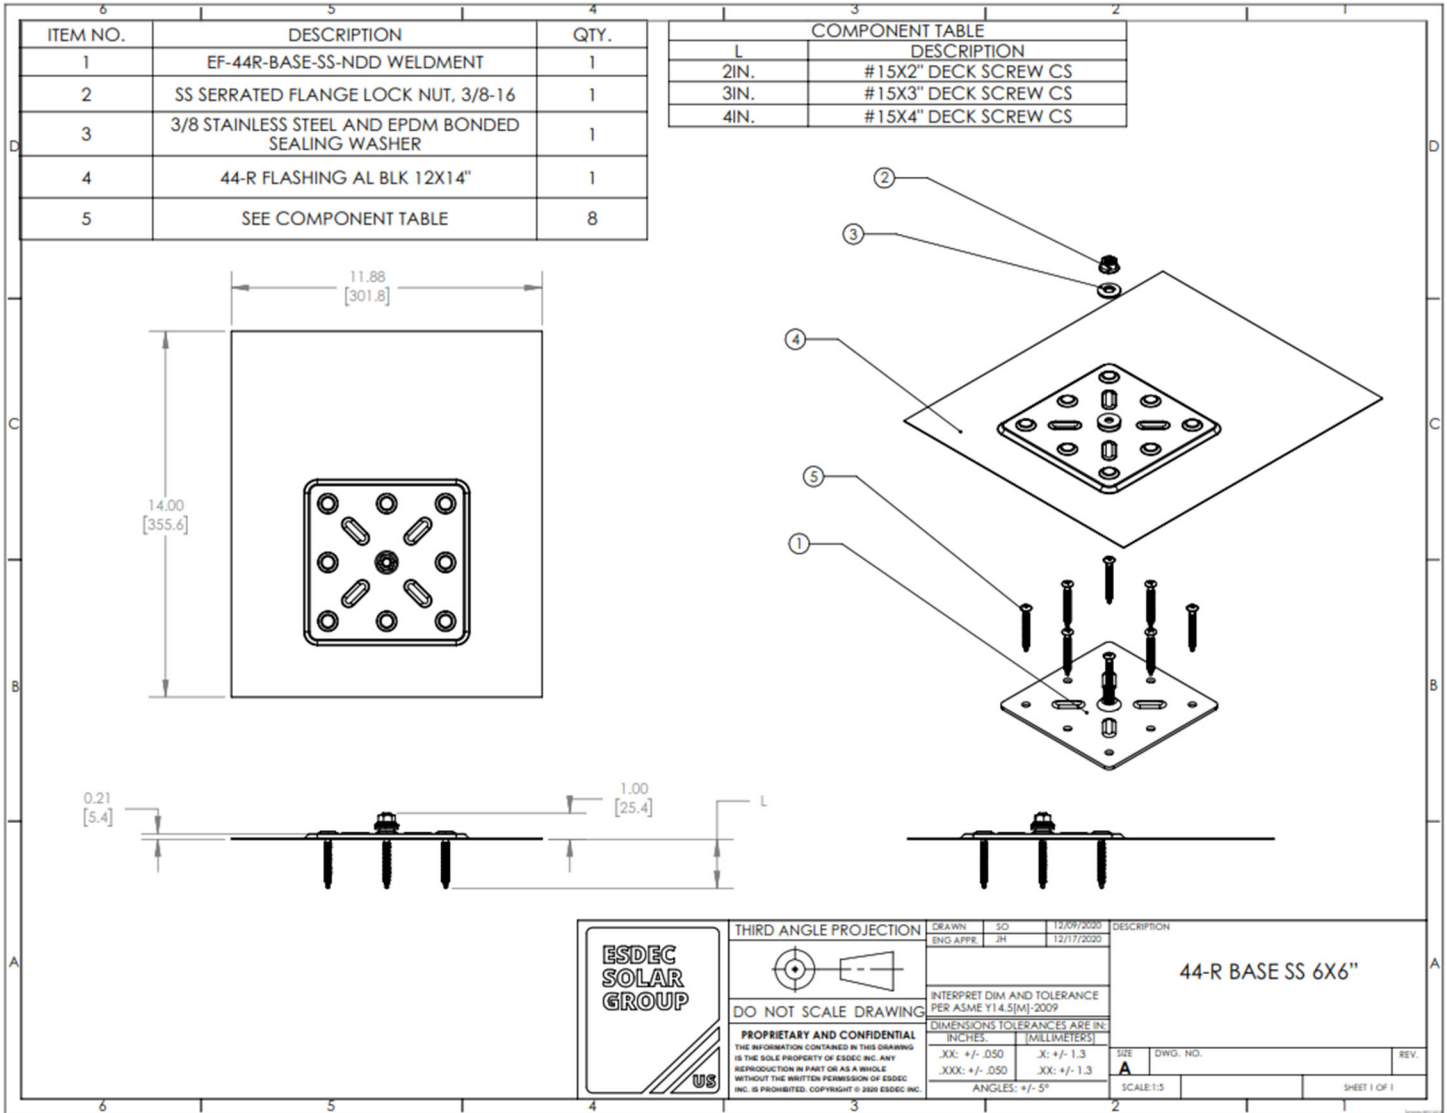
This letter provides details on the mechanical load test and certifies the structural capacity of the EcoFasten 44-R for use with flush mount railed solar systems when attached to a roof deck. The EcoFasten 44-R consists of an aluminum flashing, a stainless steel base, and a 3/8" stainless steel stud used to connect compatible EcoFasten brackets. The 44-R has holes in a square pattern about its center. The 44-R is secured to the roof deck sheathing using eight (8) No. 15 structural wood screws in these holes. Screws shall be installed in accordance with the EcoFasten 44-R installation guide. The EcoFasten 44-R details and component dimensions are shown in Appendix A.
